A. GOULD HISTORIC HOME REPORT

INSPECTION AND ESTIMATE COMPILATION

515 N WASHINGTON, OWOSSO MI 48867

Home Inspection Report

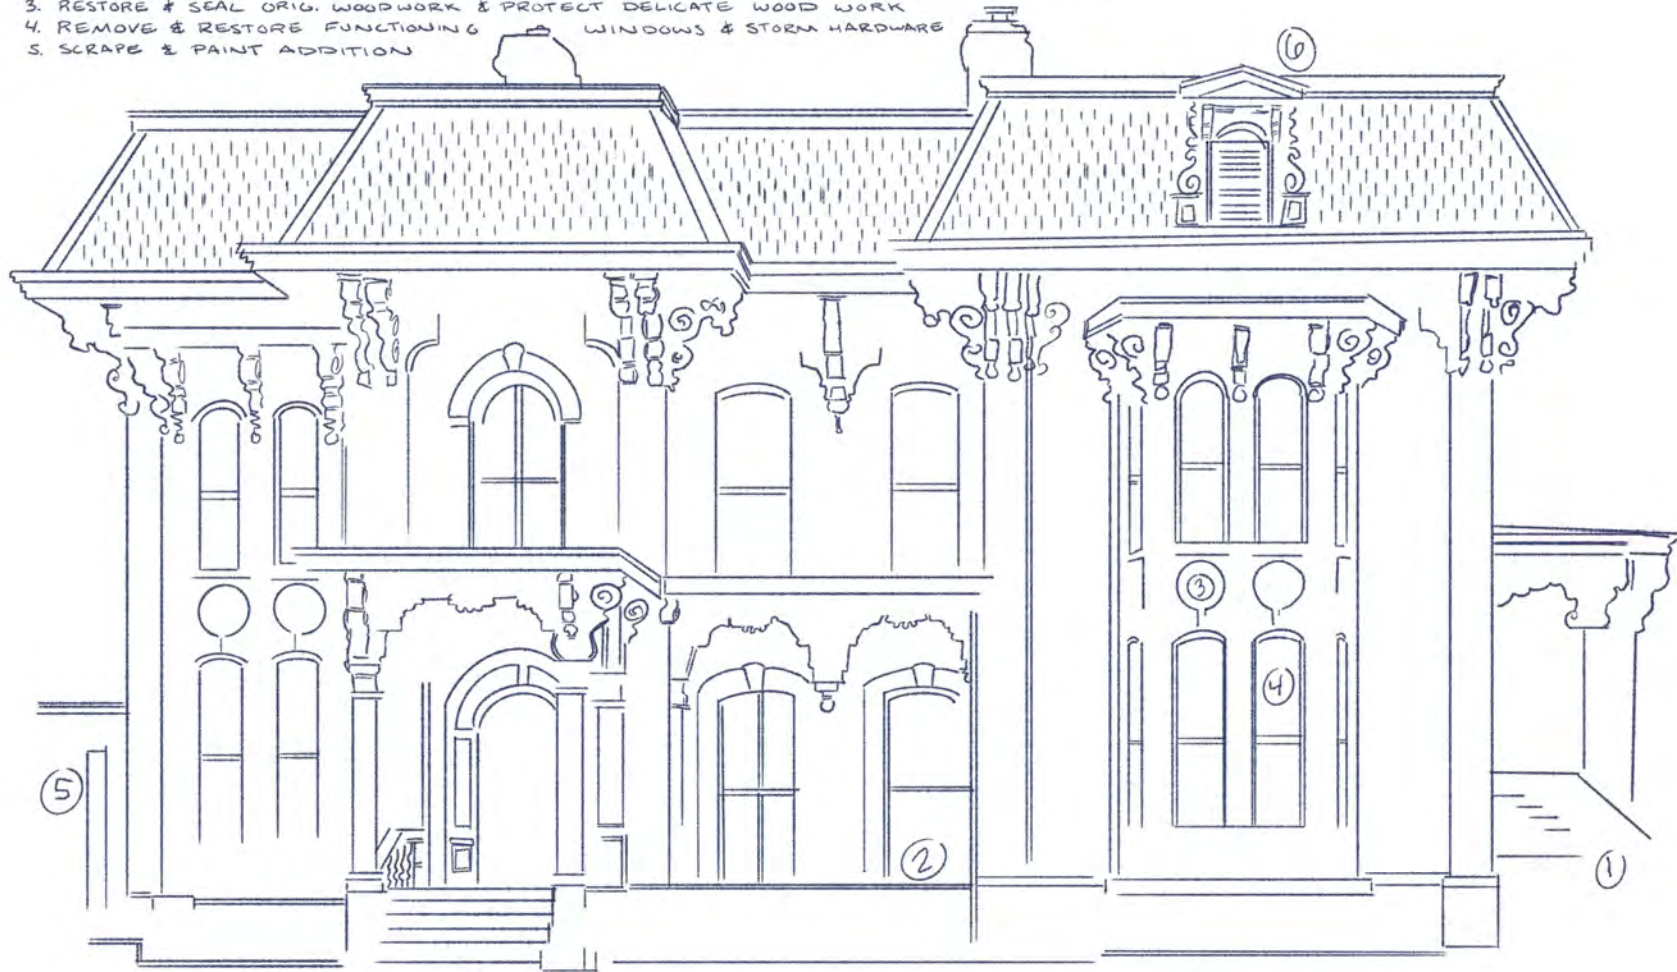
1. DAMAGED WOOD & "ALLIGATOR" PAINT - REPAIR, REPLACE, STABILIZE & ENCAPSULATE
2. JULIET BALCONY - RUSTED FENCE & WEATHERED WOOD - PAINT, REPAIR, REPLACE
3. RESTORE & SEAL ORIG. WOODWORK & PROTECT DELICATE WOOD WORK
4. REMOVE & RESTORE FUNCTIONING WINDOWS & STORM HARDWARE
5. SCRAPE & PAINT ADDITION

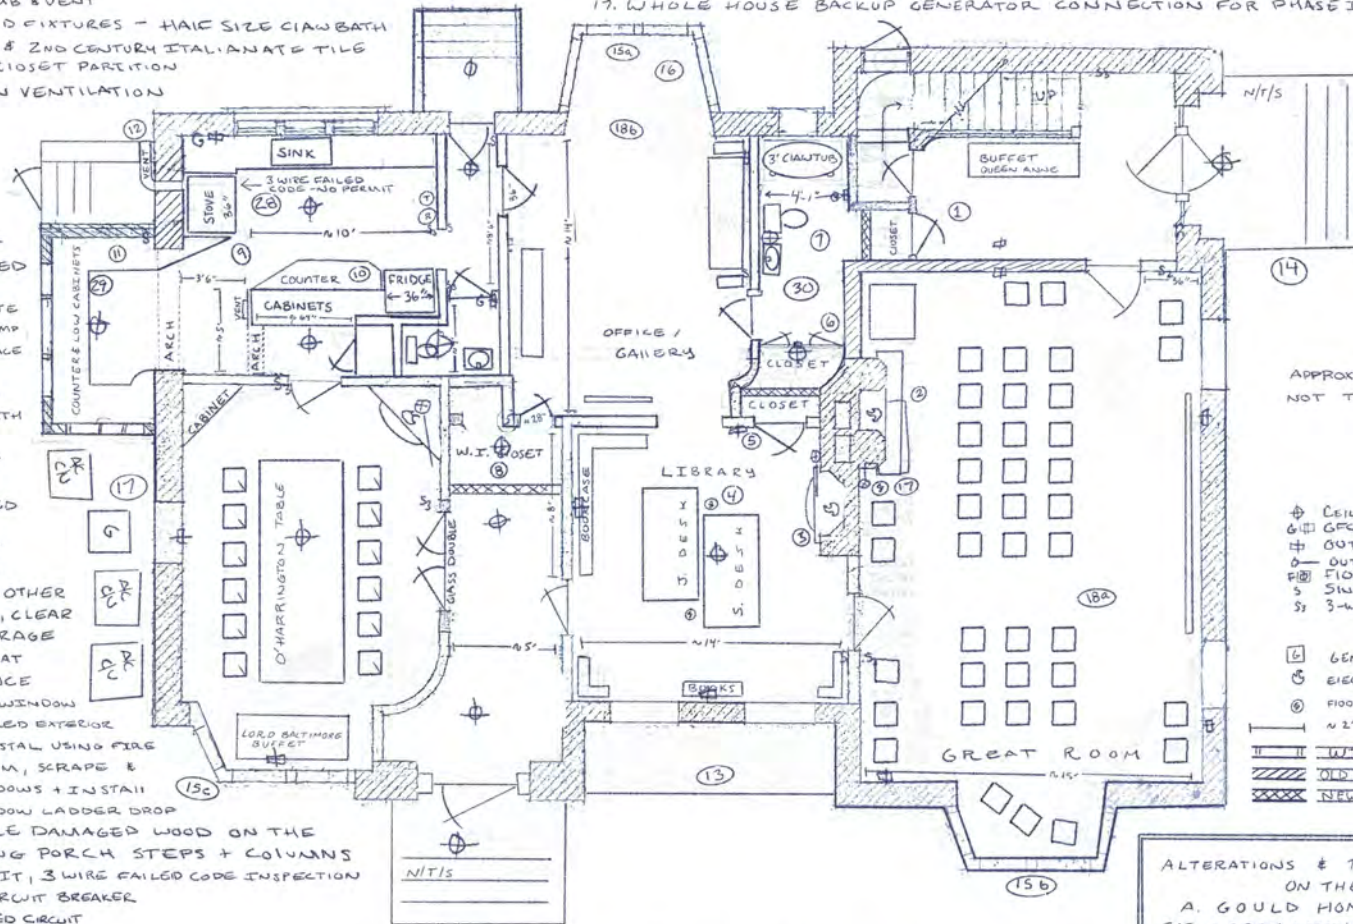
ALTERATIONS & REPAIRS
ON THE
A. GOULD HOMESTEAD
515 NORTH WASHINGTON ST.
OWOSSO MICHIGAN 48867
FOR SEAN & JAE HARRINGTON
APRIL 6, 2024 SHEET 1

1. REINFORCE HANDRAIL OVER MAIN STAIRS
2. DRYWALL CRACK ALONG CHIMNEY STACK EDGE
MAY BE RELATED TO SIMILAR CRACK RUNNING THROUGH GALLERY ON FIRST FLOOR - ADD SUPPORT BEAMS & STEEL RODS IN BASEMENT AND REPAIR JOIST IN THE BASEMENT (SEE SHEET 3)

- A, B, C, WINDOWS/EGRESS- REPAIR & RESTORE WINDOW FUNCTION
 - FIRE ESCAPE LADDER NOT INSTALLED IN BEDROOMS - INSTALL 2
4. ATTIC ACCESS ABOVE STAIRS, NO LADDER - RELOCATE & ADD DROP

5. BATH LOCATION ABOVE SUSPECTED MOISTURE RELATED PLASTER CEILING DAMAGES OVER FIRST FLOOR BED ROOM SEAL TILE/GROUT & LEAK TEST ALL FIXTURES
6. OPEN CRACKS & SEAMS ON STAIRS & TRIM
BASEMENT SUPPORT BEAMS SHOULD RESOLVE

7. TILE SHOWS SIGNS OF MOISTURE BARRIER FAILURE, STRIP, GROUT & RESEAL
8. JULIET BALCONY IRON FENCE RUSTED
9. CHIMNEY STACK, STATUS UNKNOWN - INSPECT & SCOPE TO DETERMINE SERVICABILITY OR CAP

10. CLEAN OR REPLACE CARPET
11. REPLACE KNOB & TUBE WIRES AND BRING TO CODE. ADD OUTLETS THROUGHOUT. UPDATE GFCI IN ALL ROOMS WITH WATER FIXTURES.
12. INSTALL MOISTURE MITIGATION VAPOR BARRIER AND VENTILATION IN ALL ROOMS WITH WATER FIXTURES

13. REMOVE DAMAGED CARPET & ASSESS SUBFLOOR / ORIG. FLOOR
14. REPAIR PLASTER & WALLPAPER THROUGHOUT

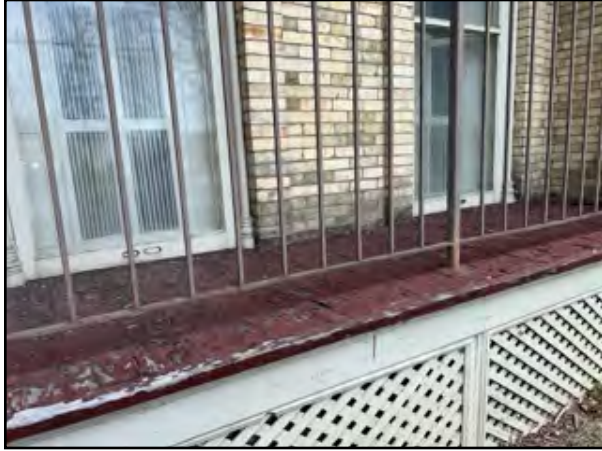
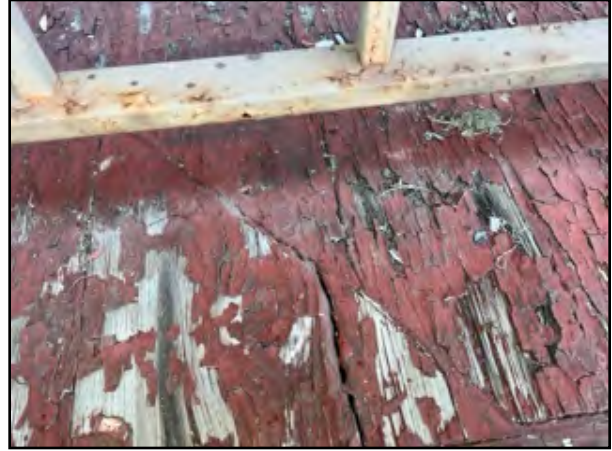
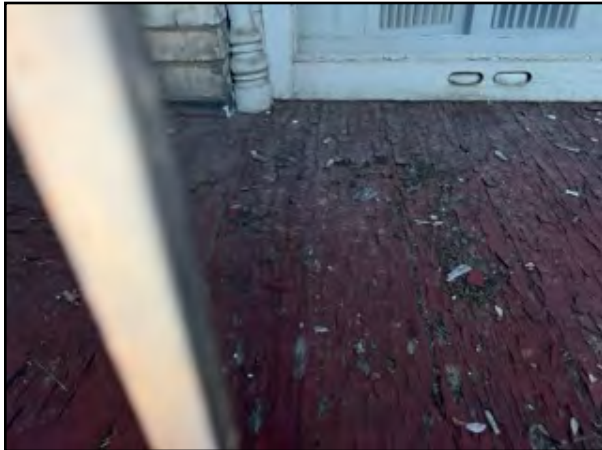
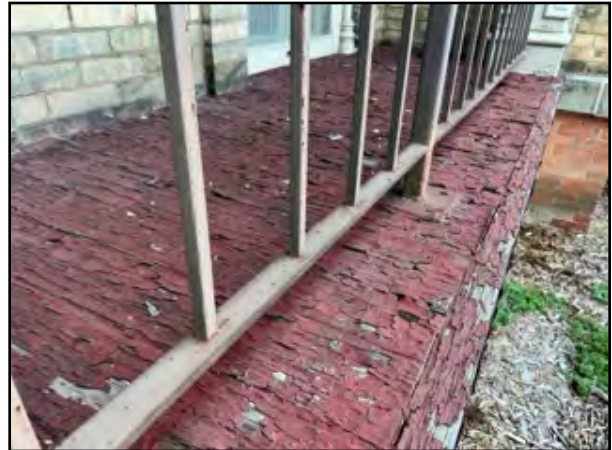
Comment 4:
Picture of the balcony with deterioration.

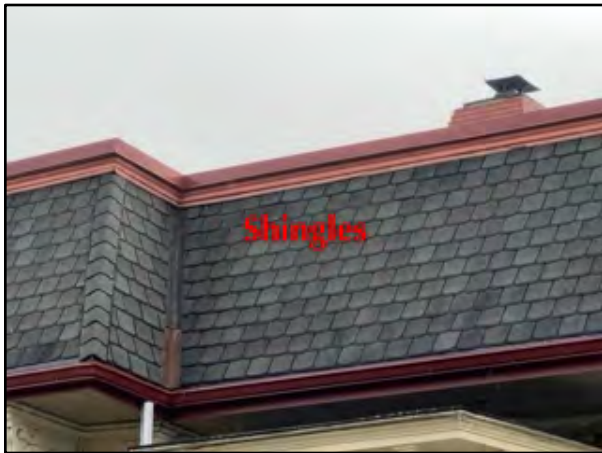
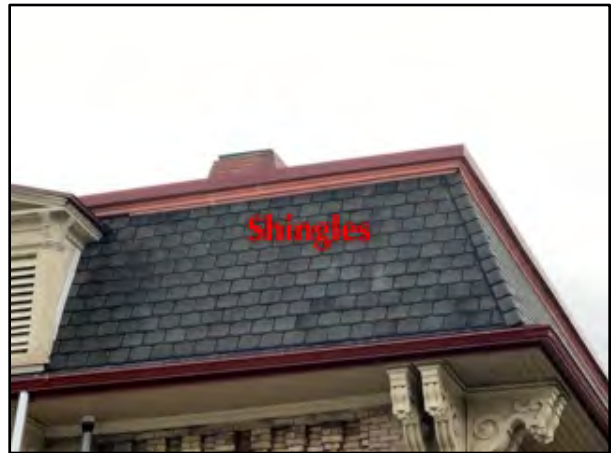
Comment 6:
Picture of the visible shingles.

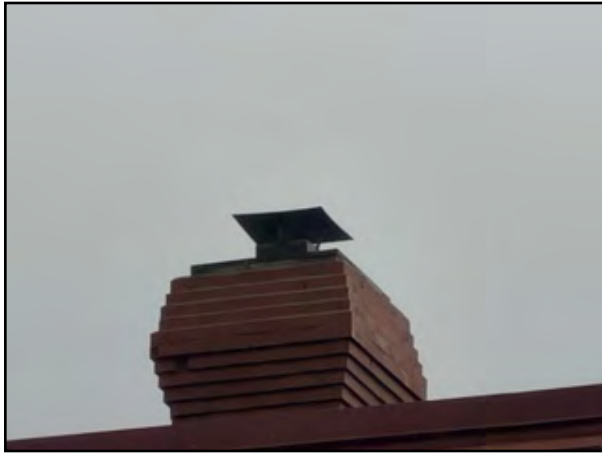
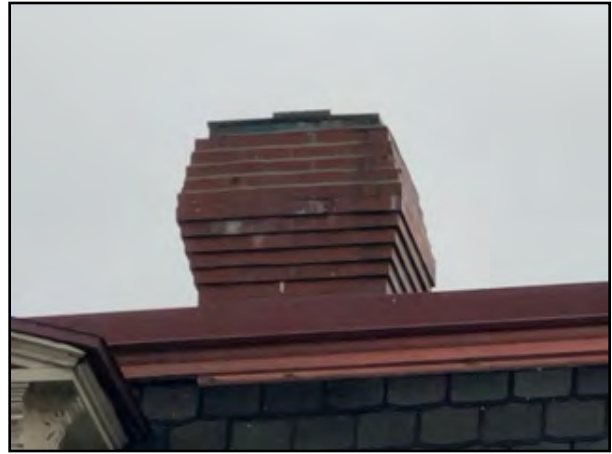
Comment 7:
Picture of the chimneys.

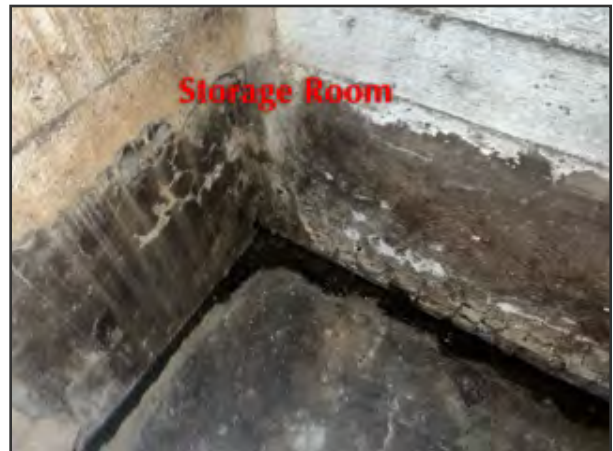
Dampness, Stains, Water
Condition: Repair or Replace

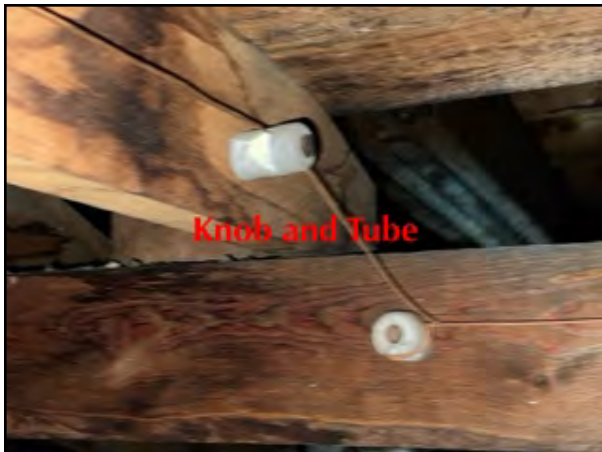
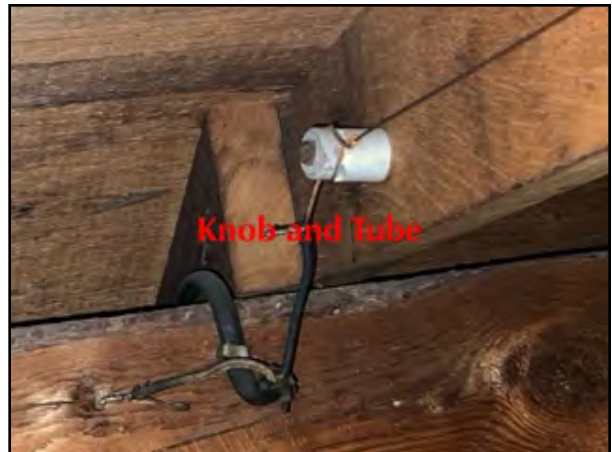
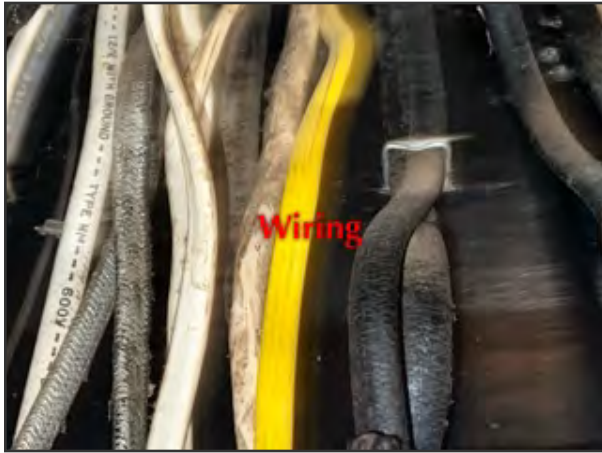
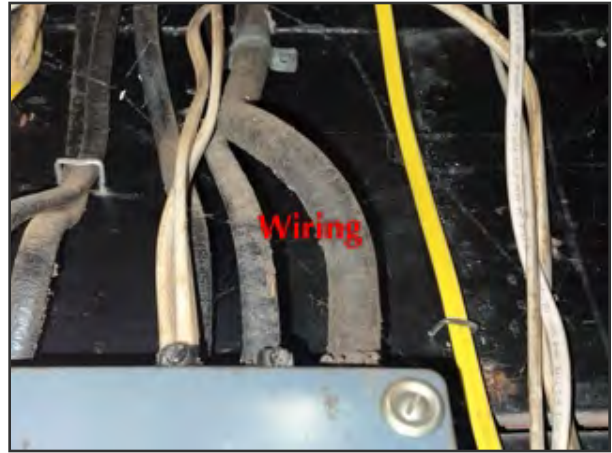
Comment 11:

Service Line Material:	Aluminum
Service Voltage:	240 volts
Service Amperage:	100 amps
Service Panel Ground:	Unknown Not Visable
Branch Circuit Wiring:	Knob and Tube in Attic, Cloth Wires
	Condition: Repair or Replace

Cloth wiring is very common to the age of this house. Although at that time it was standard building practice. I would highly recommend the wiring updated to meet today's standards for added safety.

Knob and tube was found in the attic. This is outdated wiring, and must be removed by a licensed electrician. Knob and tube is considered a safety issue based on its age. The knob and tube is most likely 100 years old.

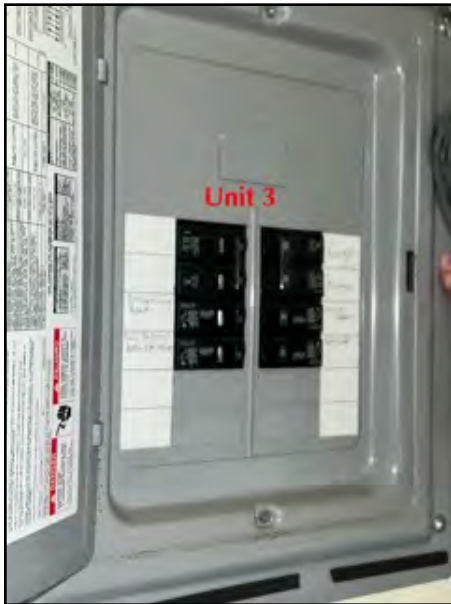
Figure 16-1

Comment 16:
Pictures of the sub panels in the basement. Sub panels are used for the air conditioner and units number two and three. Unit number one has the air conditioner powered from the main panel.

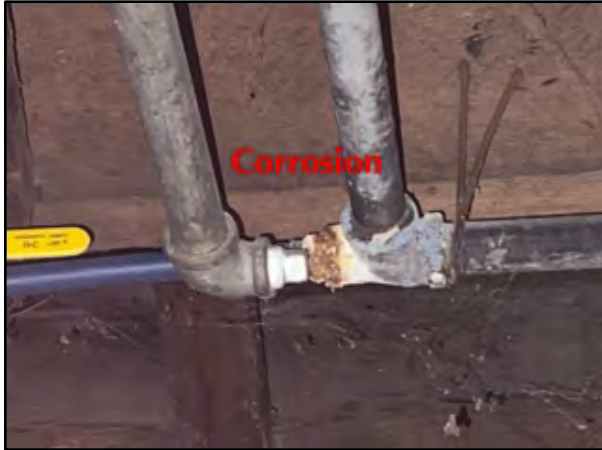
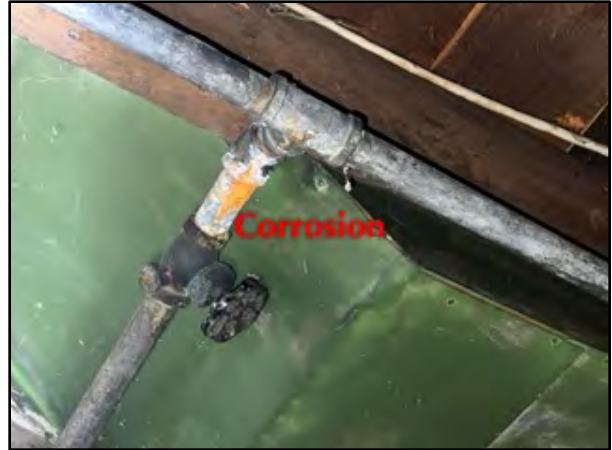
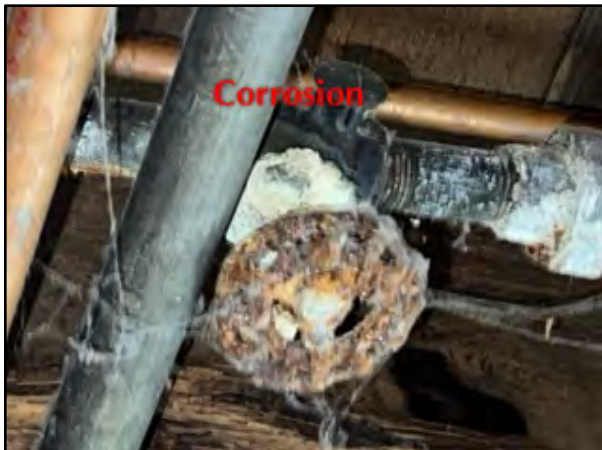
Condition: Repair or Replace

Galvanized supply lines are outdated and no longer used in today's construction. Galvanized piping can corrode from within and reduce water pressure depositing the metal flakes into the water. The pictures are examples of areas with corrosion.

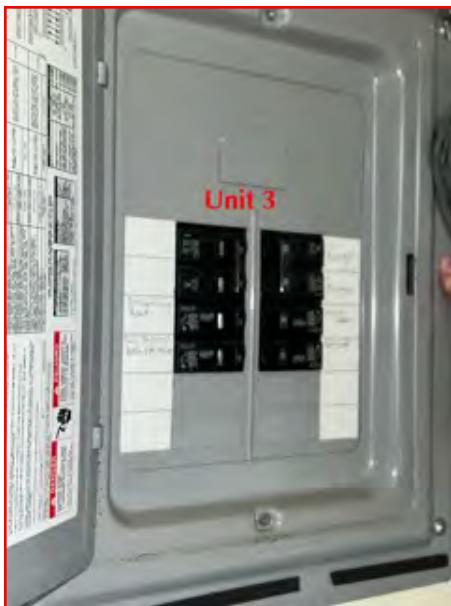
Figure 16-1

14) Pictures of the sub panels in the basement. Sub panels are used for the air conditioner and units number two and three. Unit number one has the air conditioner powered from the main panel.
