# CITY OF OWOSSO

## DRINKING WATER REVOLVING FUND PROJECT PLAN

DRAFT FOR PUBLIC NOTICE - MARCH 11, 2019

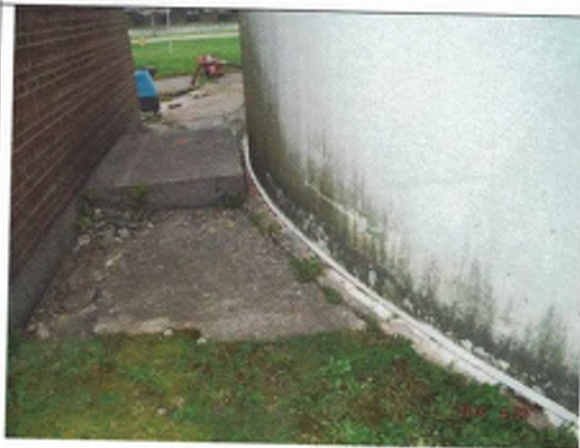
Coating break along lower exterior sidewall

The elevated storage tank and the standpipe are in need of major repair including, but not limited to, abrasive blast cleaning and recoating of interior and exterior surfaces due to corrosion. Further analysis of the storage facilities are presented in the Analysis of Alternatives section of this report.

Water Storage inspections performed by Nelson Tank Engineering and Consulting (NTEC) in 2016 included repair recommendations for the 0.6 million gallon elevated tank and a 1.25 million gallon standpipe. These primarily consist of abrasive blasting and recoating of the structures' interior and exterior surfaces and replacing minor miscellaneous equipment (e.g., ladder, valve, vent, mixing equipment). The tasks listed in the NTEC report are essential for the long-term operation and maintenance of the storage tanks. The 2018 DEQ Sanitary Survey recommends following the conclusions of the 2016 NTEC inspection. The summaries of the maintenance inspection reports written by NTEC for each structure are included in Appendix D.

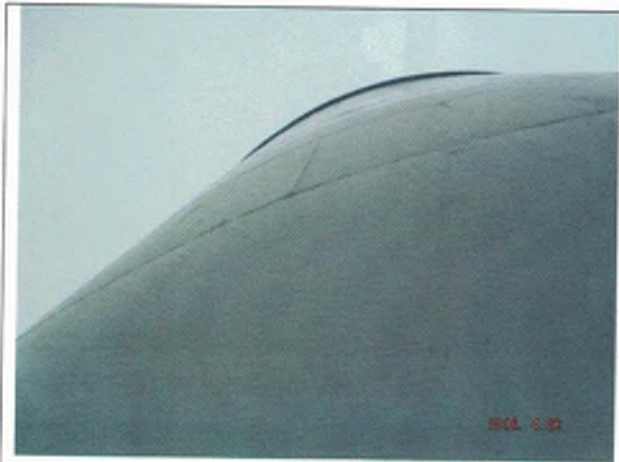
Spalling of foundation

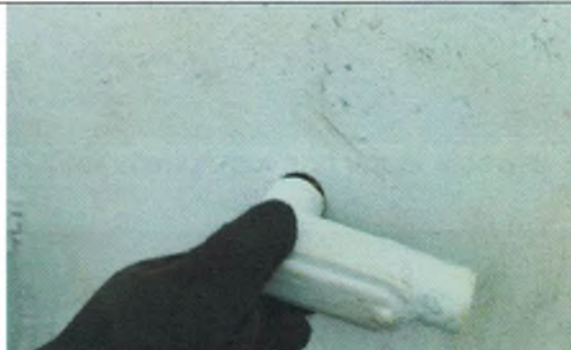
Cut off obsolete conduit on exterior roof

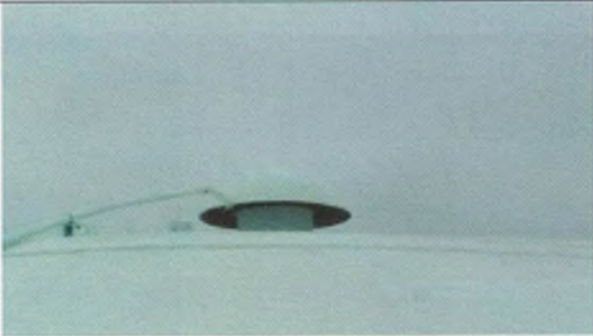
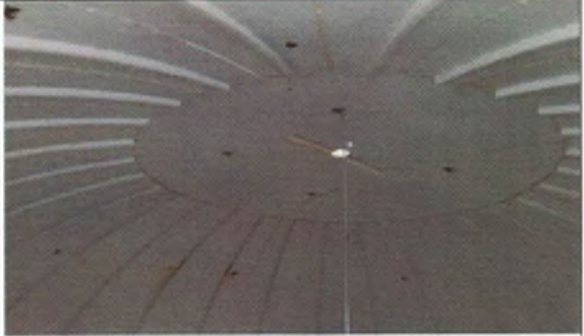
Obsolete conduit entering tank roof is loose

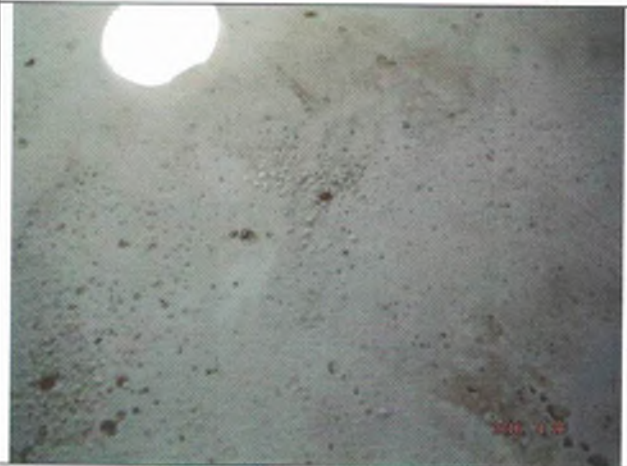
Blistering of coating on floor

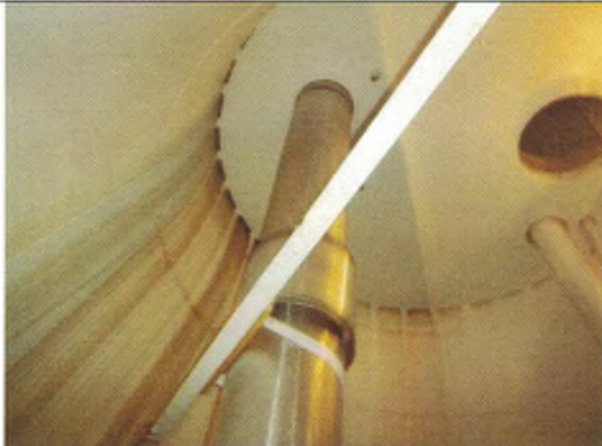
Basebell ladder

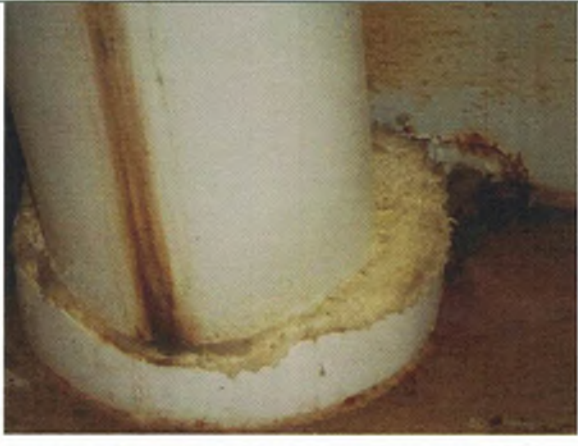
Fill pipe; staining on upper basebell wall
