IDENTIFICATION OF UGLG

Project Title/Name: Howard Street Development

Project
152 East Howard St
Owosso, MI 48867

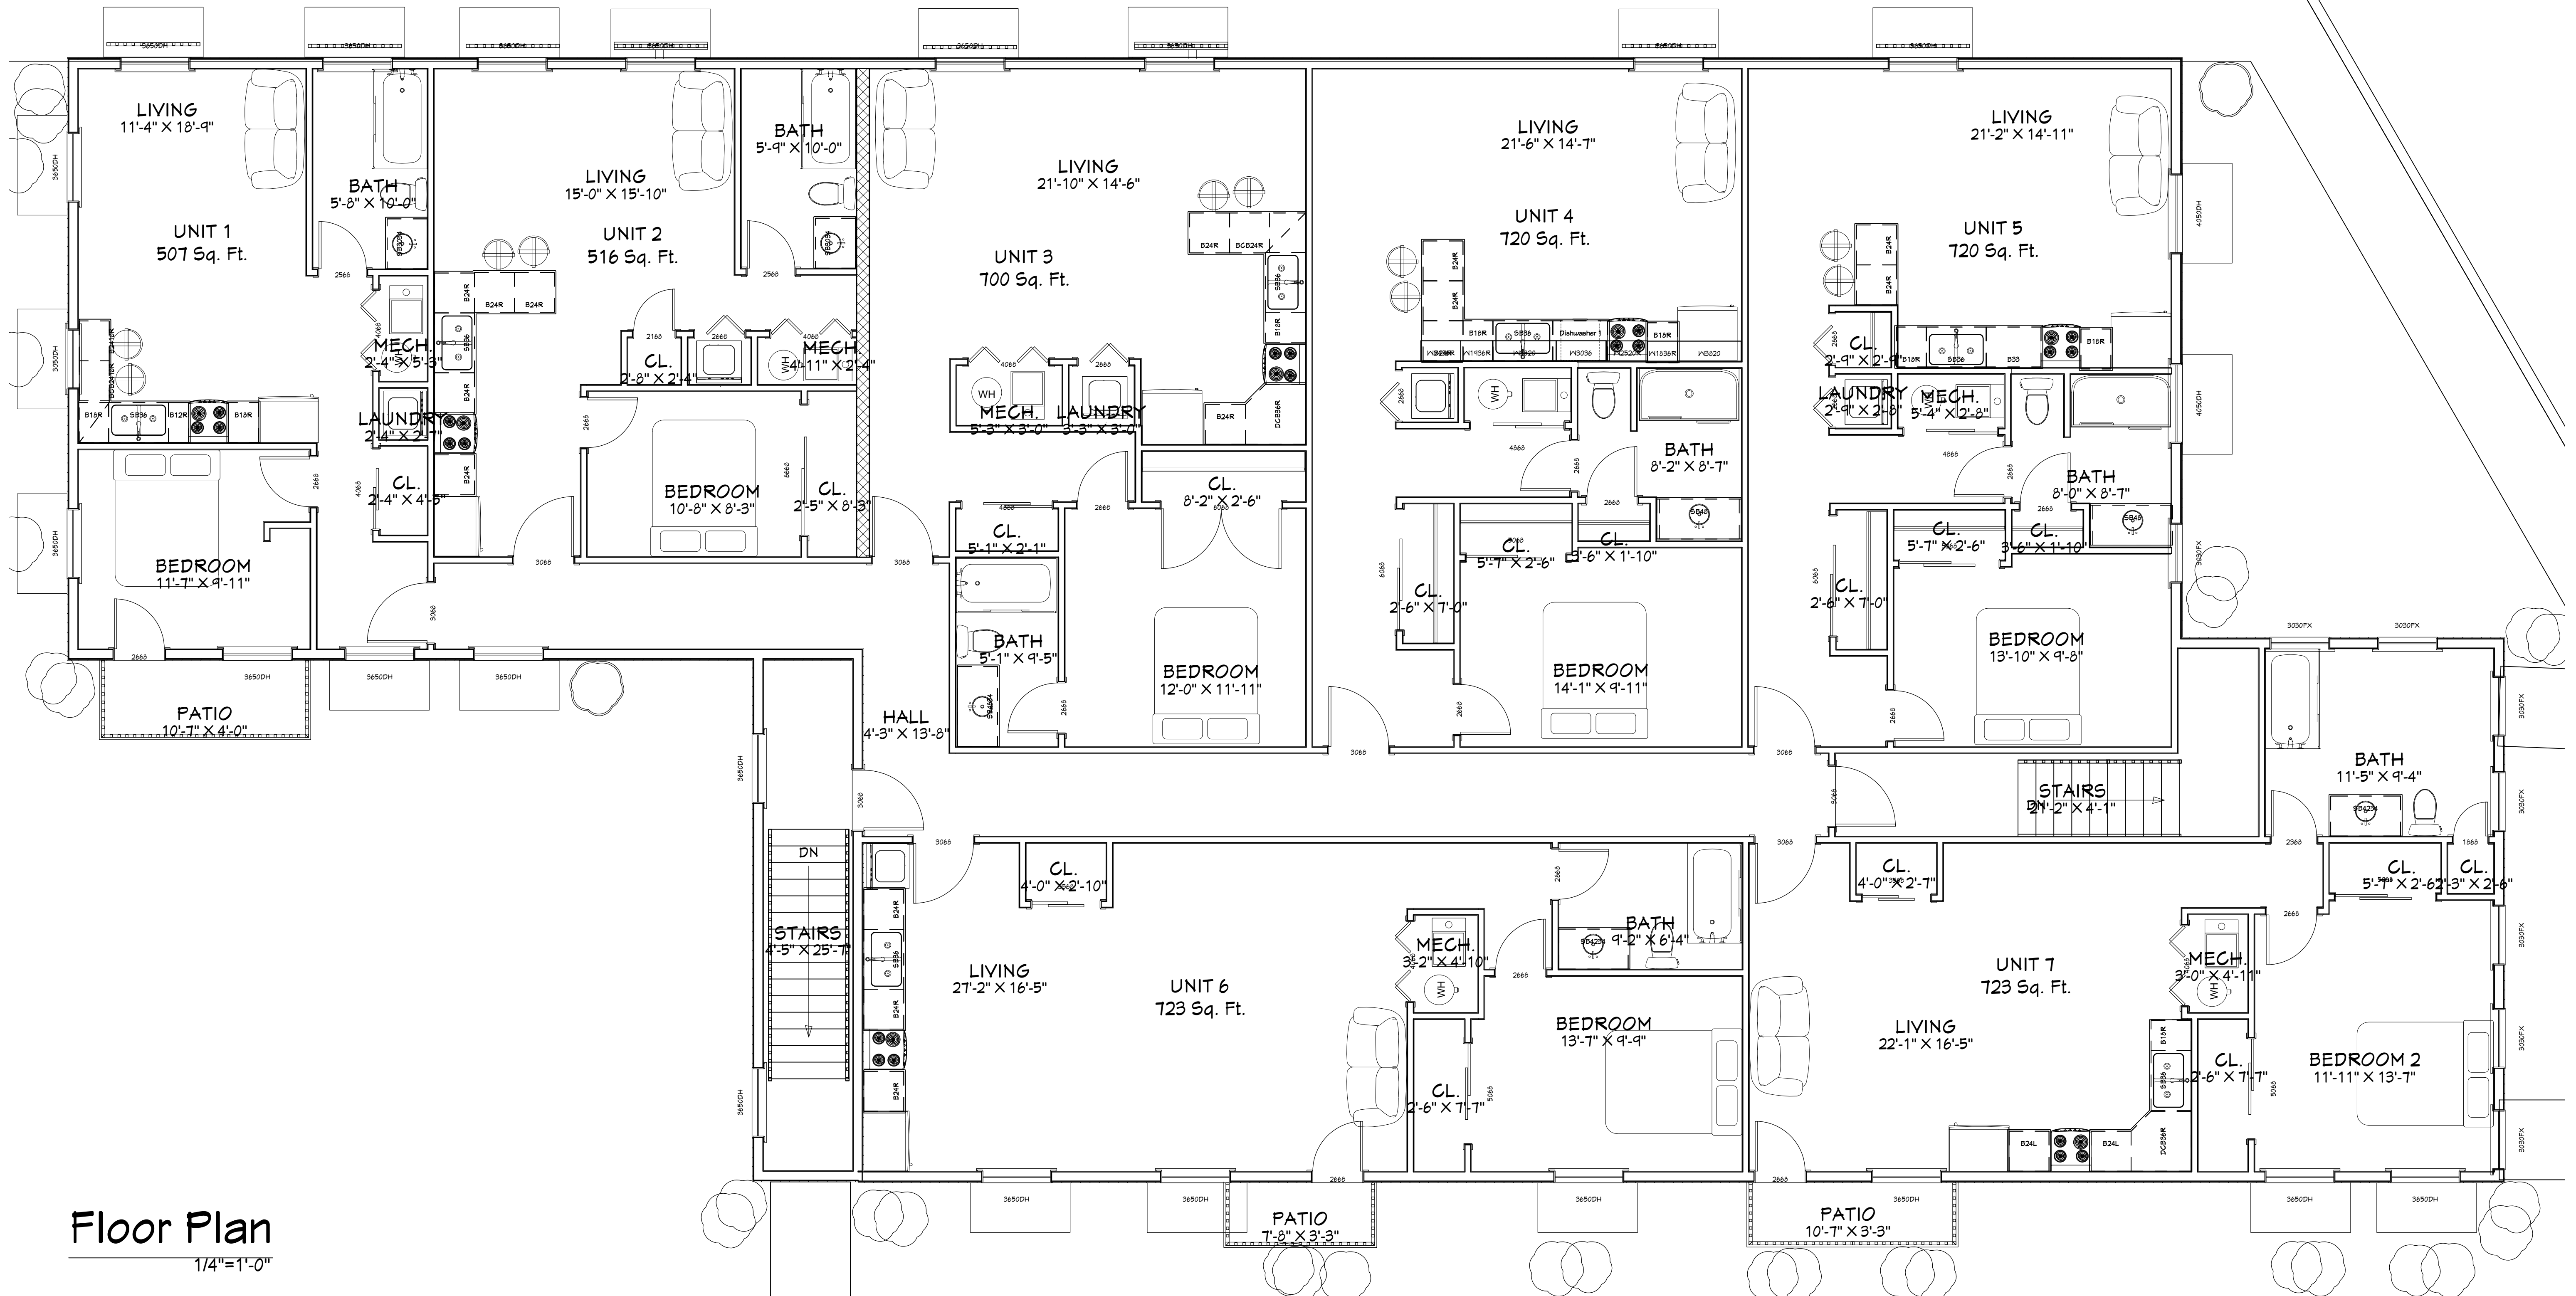
Floor Plan
1/4"=1'-0"

Drawing
Floor Plan

Floor Area: 4,240 Sq. Ft.
 Use group: R-2 Residential
 Construction Type IIIB MBC Table 601
 Allowable # Stories MBC Table 504.4: 4 Stories
 Allowable Square Footage Table 506.2: 16,000 sq. ft.
 Frontage Increase: Not Required
 Sprinkler required per MBC 903.2.8
 Occupancy @200 sq. ft. = 22 per floor MBC Table 1004.1.2
 Two exits required per MBC Table 1006.3.2(2)
 Elevator not required per MBC 1004.2.1

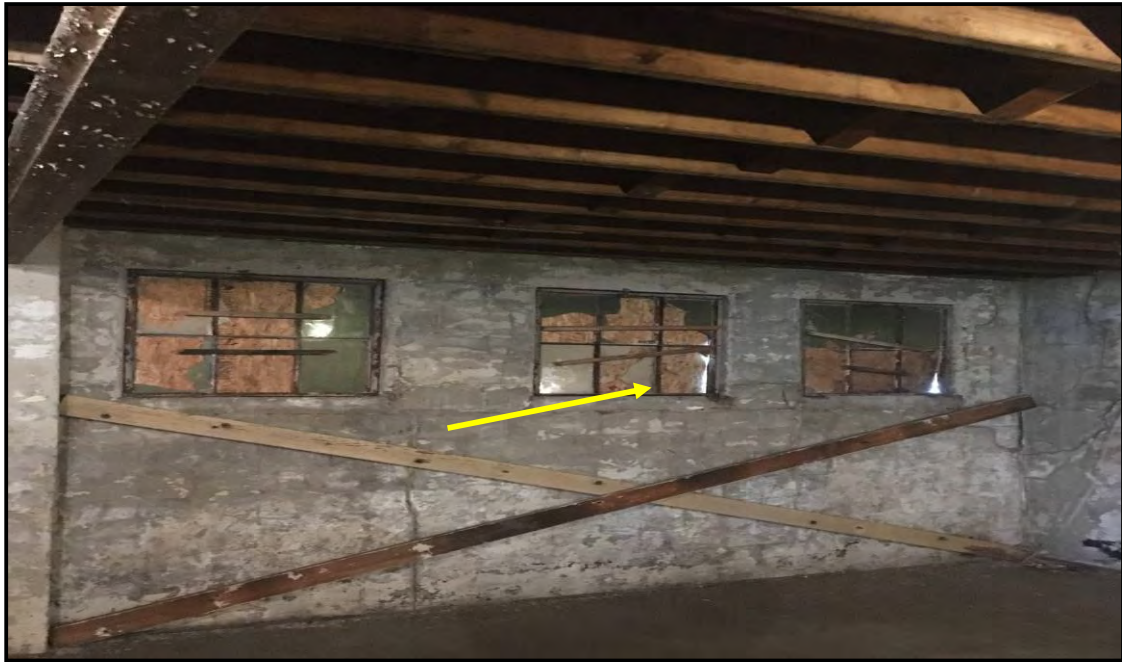
PHOTO: 1 **DATE: 2/22/2019** **BY: Greg Ross**
SUBJECT: HA 1: Asbestos-containing glazing on the metal frame windows located in the eastern portion of the building on the second floor (10 windows total).

| PROJECT ACTIVITY | PROJECT ACTIVITY DESCRIPTION | COST ESTIMATE |
|---|--|---|
| Asbestos Abatement | Abatement estimate of Asbestos found in Residential area for identified metal window glazing on 2nd floor. Part of Contractors estimate. | \$ 1,500 |

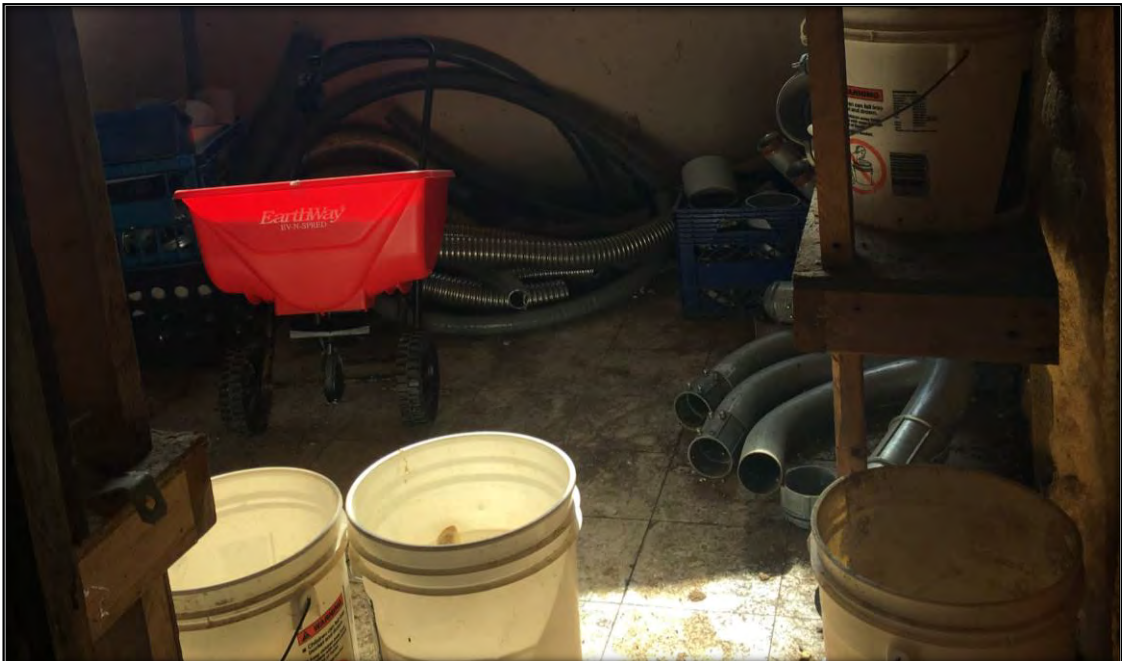
PHOTO: 2 **DATE: 2/22/2019** **BY: Greg Ross**
SUBJECT: HA 4: Asbestos-containing 9x9-inch floor tile located in the storage area (with shower), south of Ludington Electric's shop.
