A. GOULD HISTORIC HOME REPORT

INSPECTION AND ESTIMATE COMPILATION

515 N WASHINGTON, OWOSSO MI 48867

Home Inspection Report

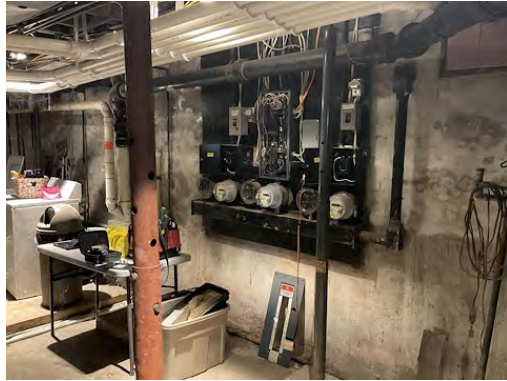
Meter Socket

In basement, all service equipment appears to be original to home. These meters should be outside of home and accessible to power company.

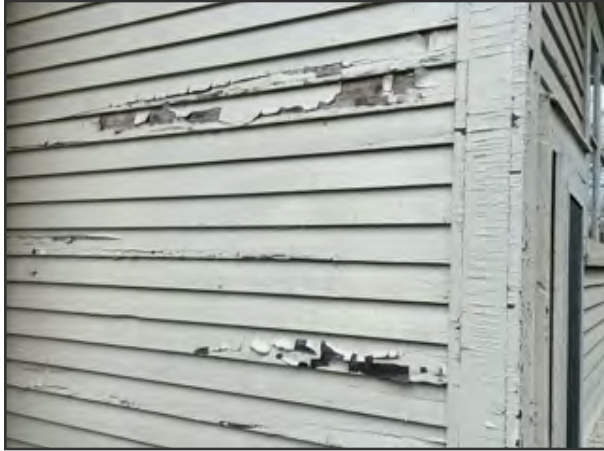
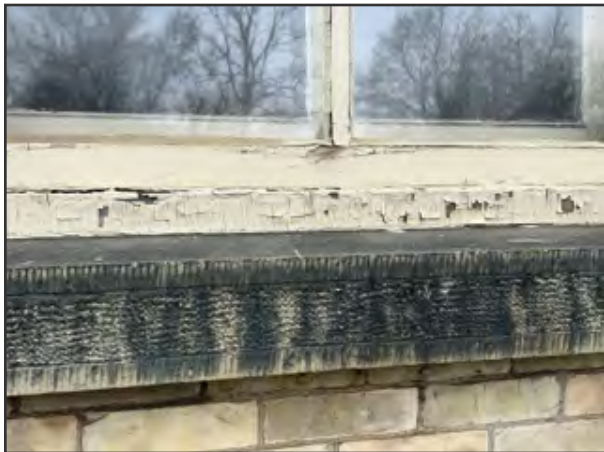
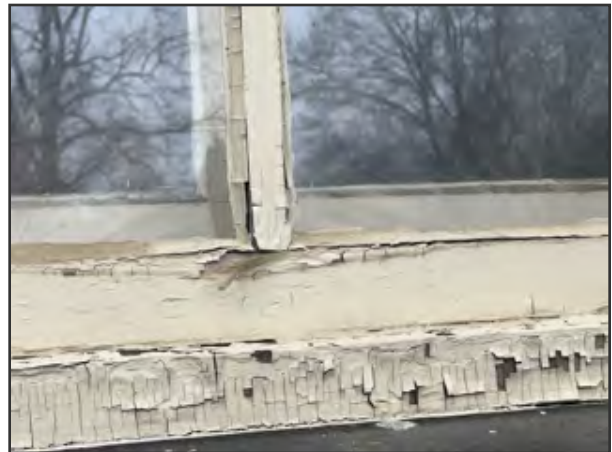
Exterior Trim Material:

Wood

Condition: Further Evaluation Required

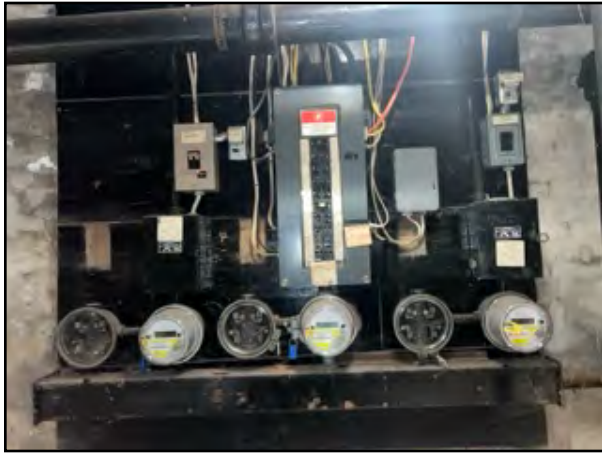
Figure 14-1

A pushmatic Panel is present. This is a panel that was used primarily between the 1950s and early 1980s. Unlike today's panels it does not operate from left to right. It pushes inward. A significant safety issue is the spring located behind the breaker. Over the years it can become corroded, rusted and brittle. This can result in the breaker not tripping if needed or if tripped by hand the circuit may not reset and remain with no power. Replacement parts are almost impossible to find and there are parts that are labeled pushmatic compatible. However these parts are not approved under the electrical code. Pushmatic breakers use a thermal design mechanism to trip the breakers and current breakers use a thermal and magnetic mechanism to trip the breakers which is safe and reliable. A licensed electrician will be needed to upgrade the electrical panel to meet current standards for safety.

Comment 14:
Picture of the electrical in the basement.

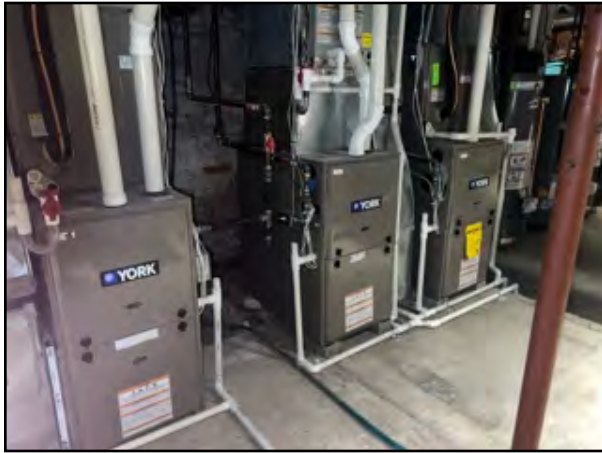
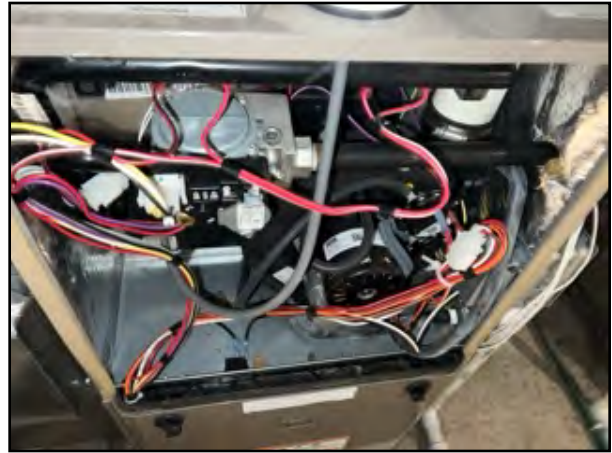
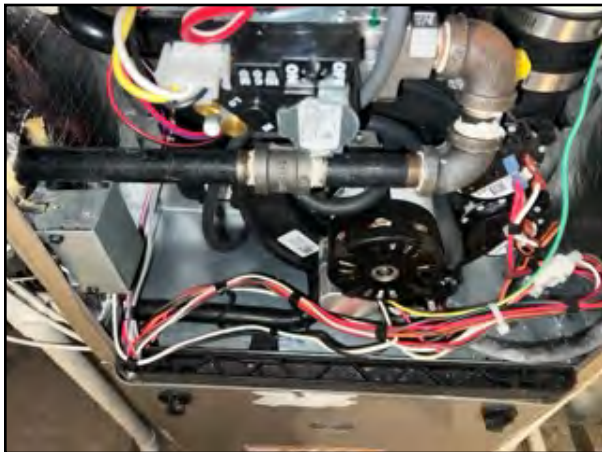
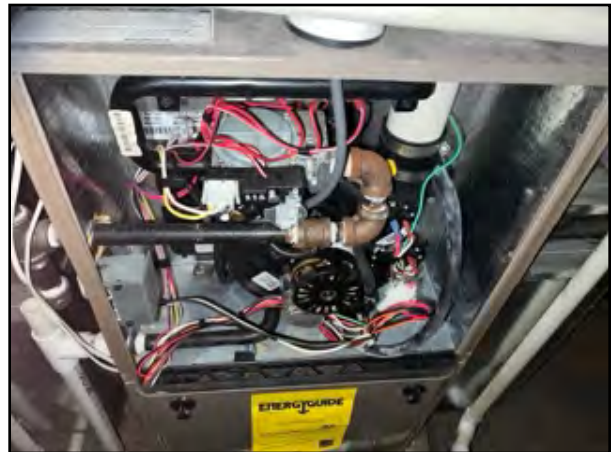
Pictures of the three furnaces. The furnaces operate at this time. The furnace is functional today, but this does not guarantee that the furnace will function properly in the future. A Furnace must be maintained and serviced by a licensed heating and cooling technician each year prior to use. The heat exchanger is not visible during a home inspection, and it is beyond the scope and ability of this home inspector to dismantle a furnace and view a heat exchanger. Therefore, the heat exchanger should be considered not inspected at this time.

Furnaces over 10 years old should be checked, cleaned and serviced yearly by a licensed contractor.

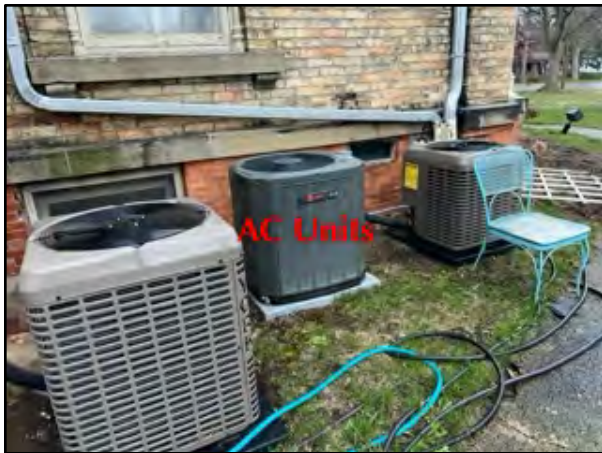
Figure 18-1

When the temperatures are below 65° I am not permitted to operate an air conditioner because it can cause damage to the system.

Air conditioners over 10 years old and heat pumps over 5 years old should be checked, cleaned and serviced yearly by a licensed contractor.

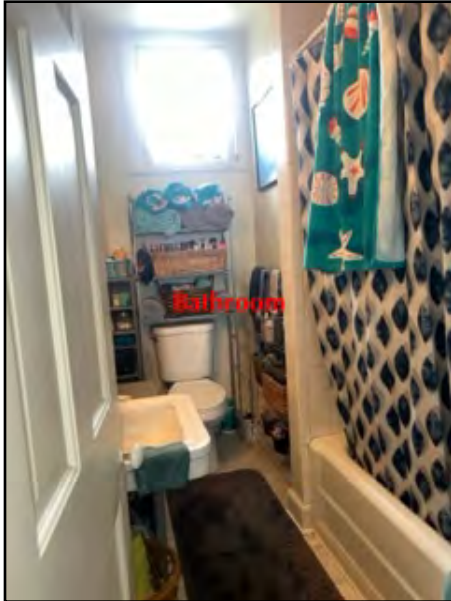
Comment 23:
Picture of the bathroom in unit #3 .

Add a power ventilator to properly route the moisture to the exterior. At the time of construction the window is proper and can still be used.

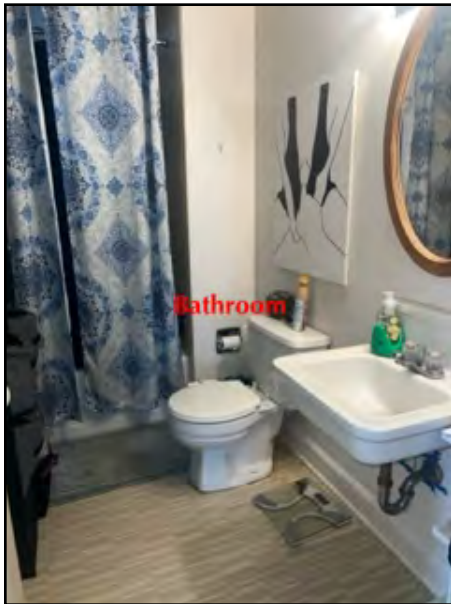
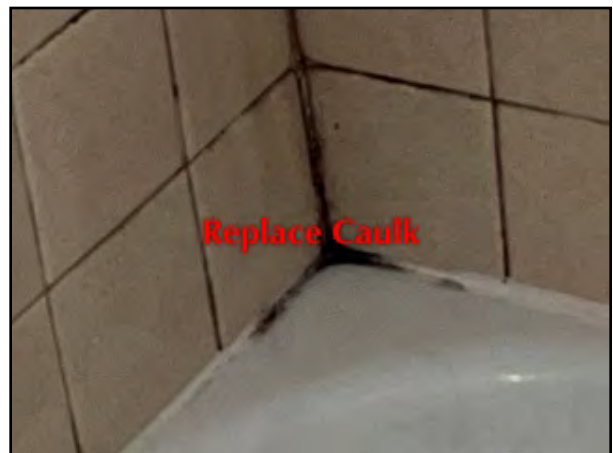
Comment 27:
Pictures of the bathroom and unit #2.

Add a power ventilator to properly route the moisture to the exterior. At the time of construction the window is proper and can still be used.

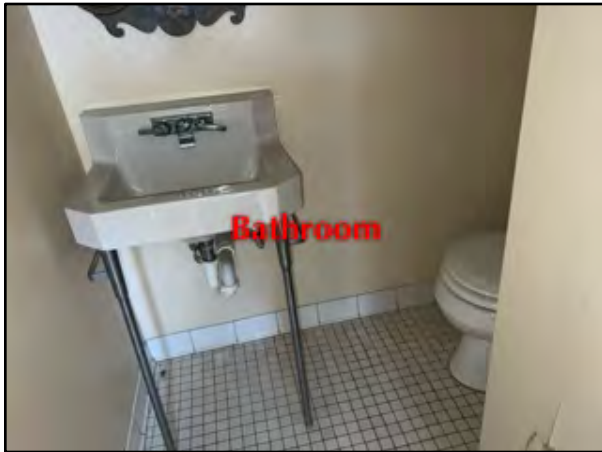
Figure 28-1

Comment 28:
Picture of the bathroom to the first floor area.

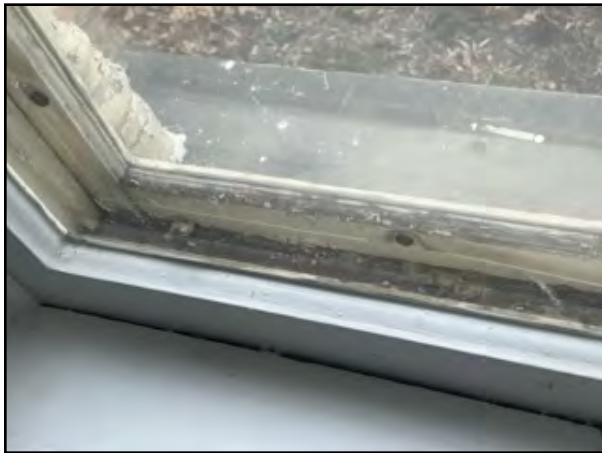
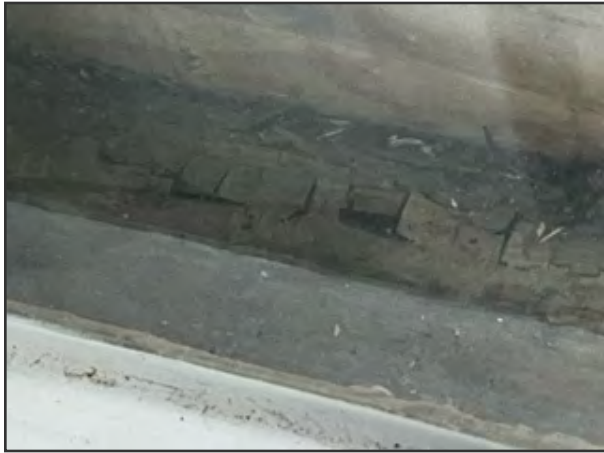
The windows will not open. Peeling paint is present in some windows. The pictures are examples. Are they

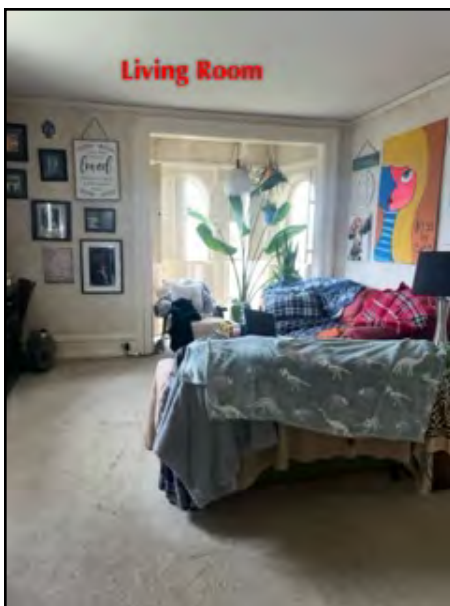
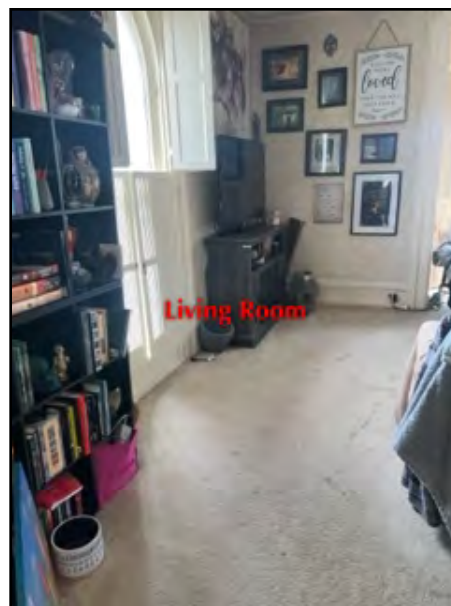
Comment 32:
Pictures of the living room to Unit 2.

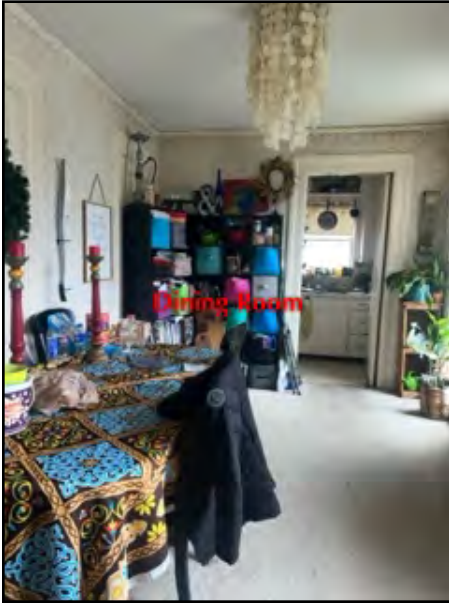
Figure 36-1

Comment 36:
Picture of the dining room Unit 2.

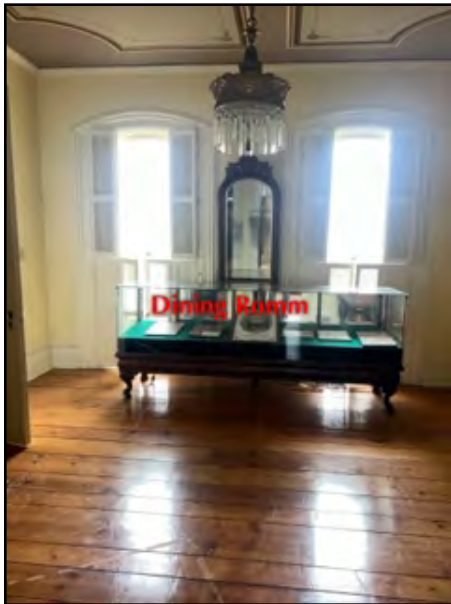
Figure 37-1

Comment 37:
Picture of the dining room Unit 1.

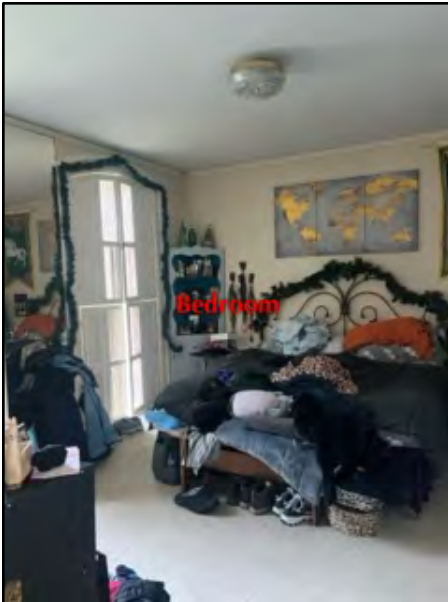
Figure 41-1

Comment 41:
Unit 2.

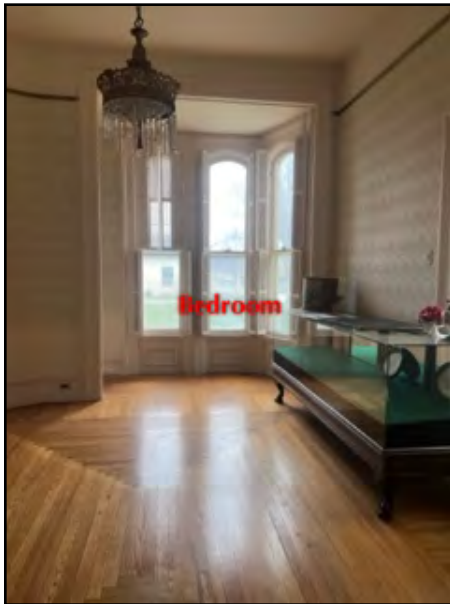
Figure 45-1

Picture of the bedroom in unit number one off the kitchen.

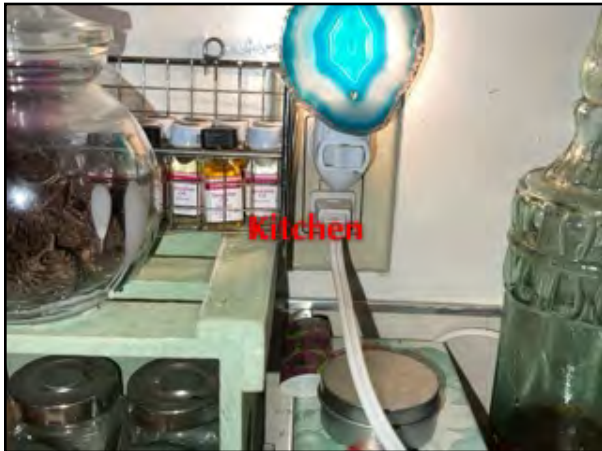
Figure 46-1

The GFCI outlet shows an open ground and does not trip when tested with a diagnostic tester.

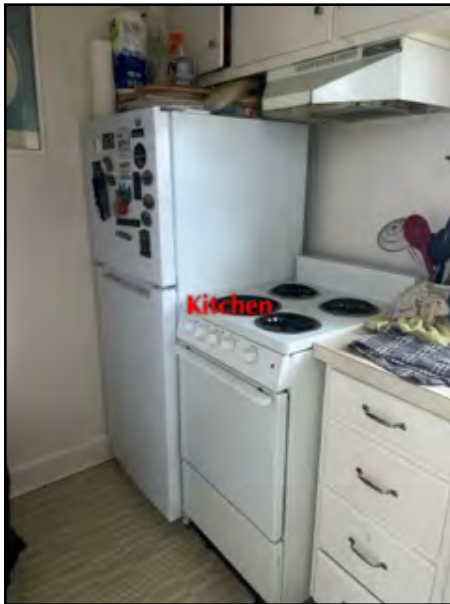
Figure 47-1

Comment 47:
Unit 2.

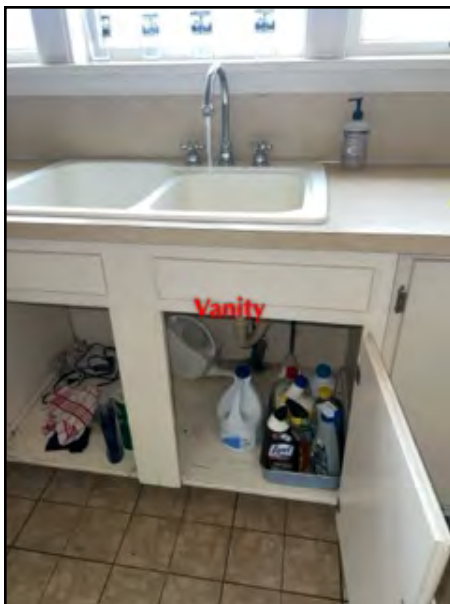
Figure 48-1

Comment 48:
Unit 1.

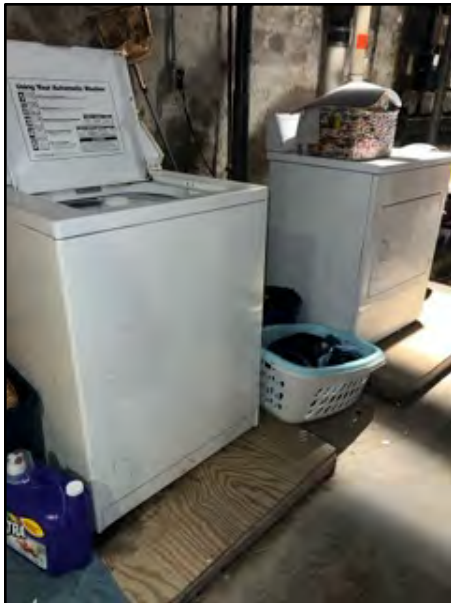
Figure 50-1

Comment 50:
Picture of the laundry area in the basement.

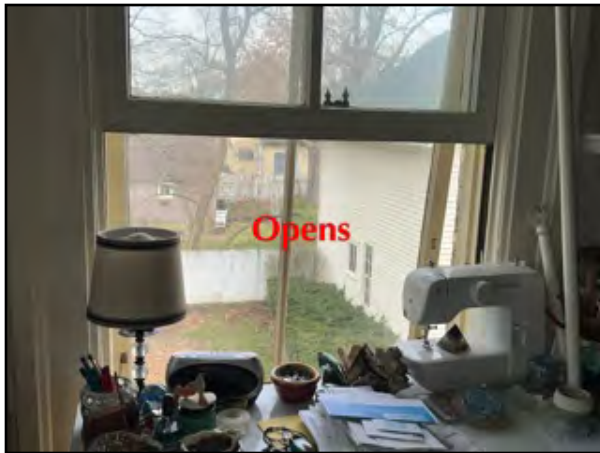
Figure 54-1

Most of the wood windows do not open in unit 3.

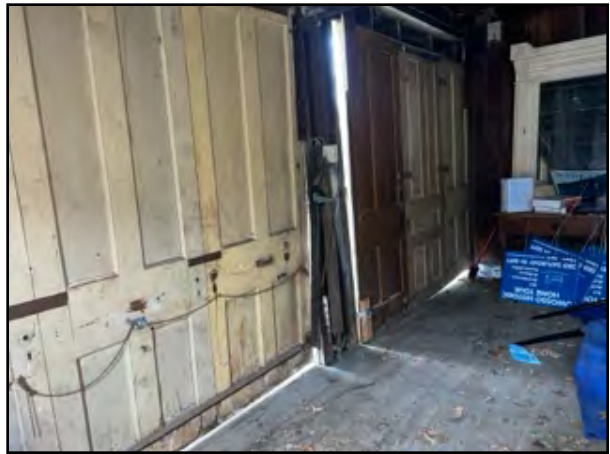
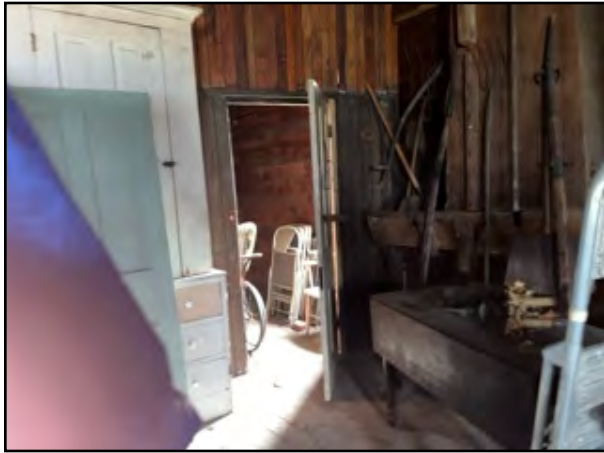
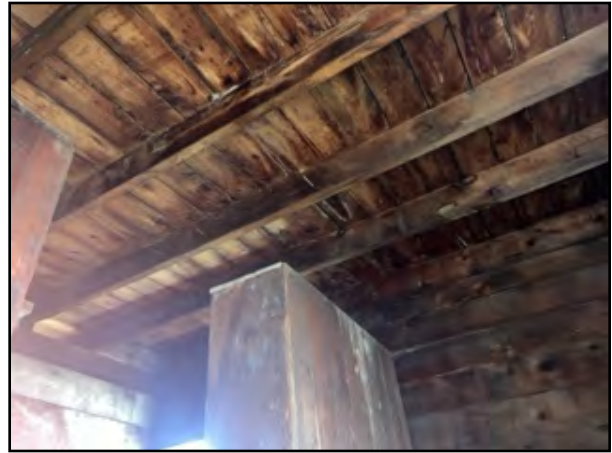
Comment 59:
Interior.

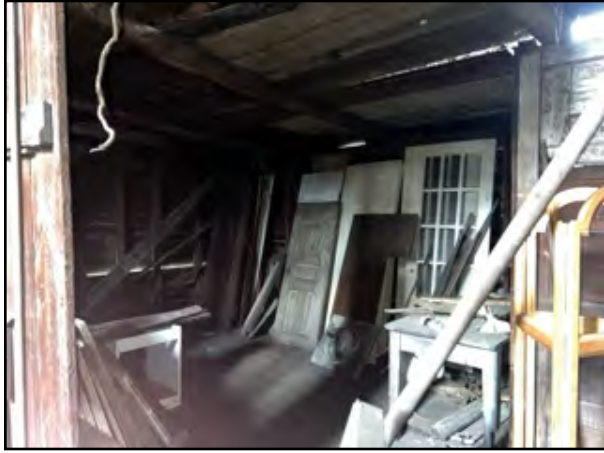
Comment 60:
Second floor.

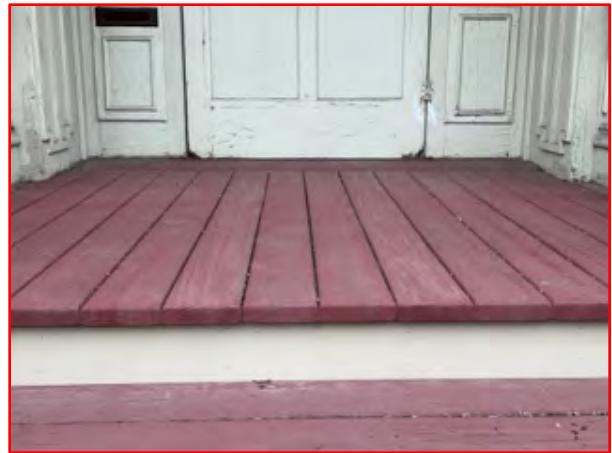
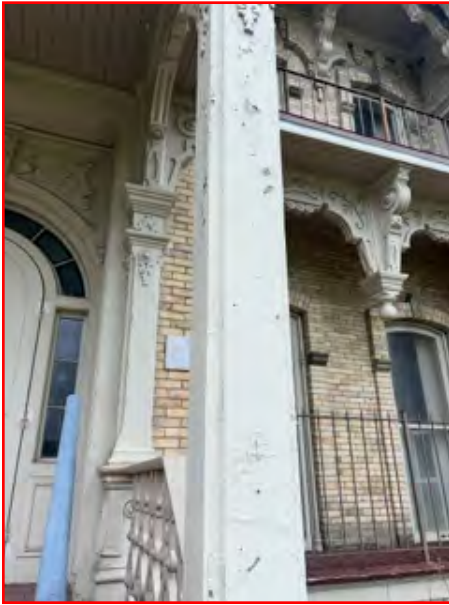
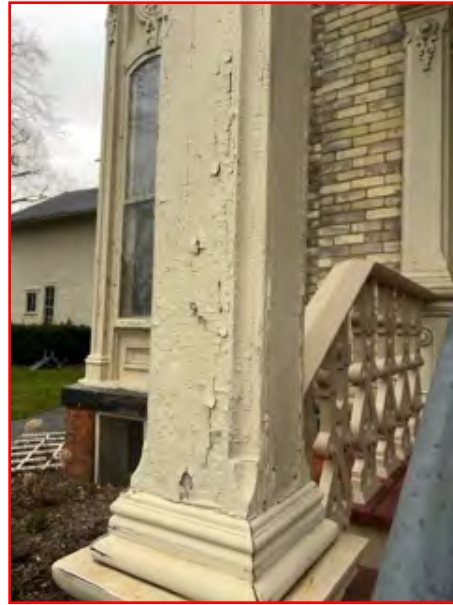
1) Side entry.

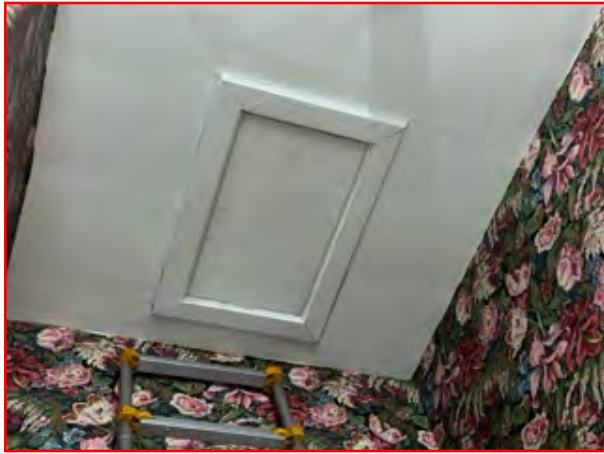
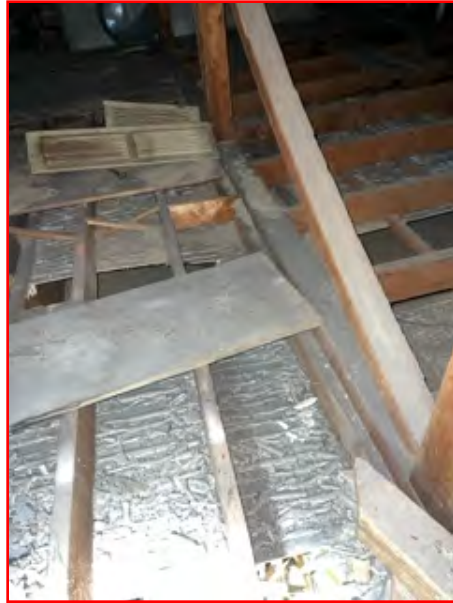
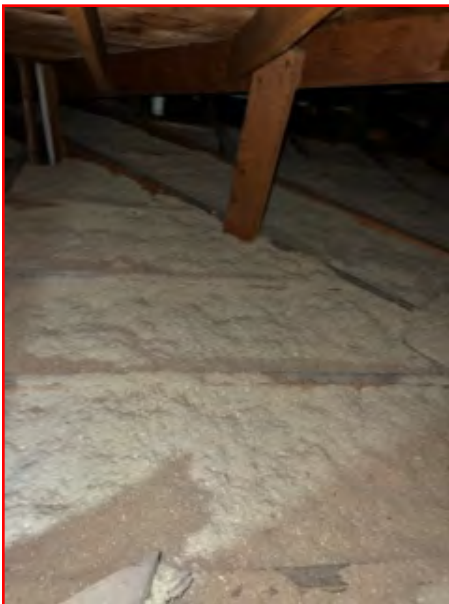
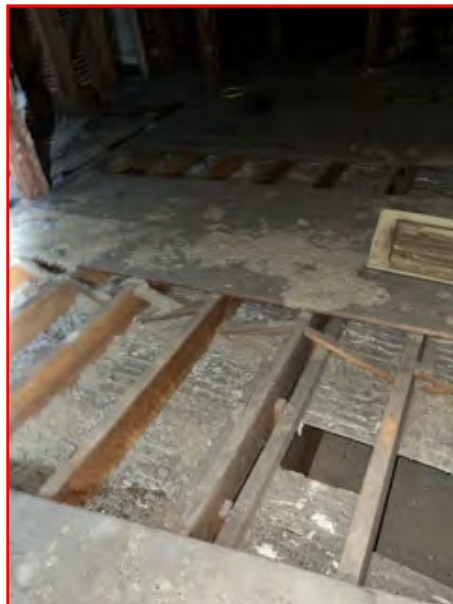
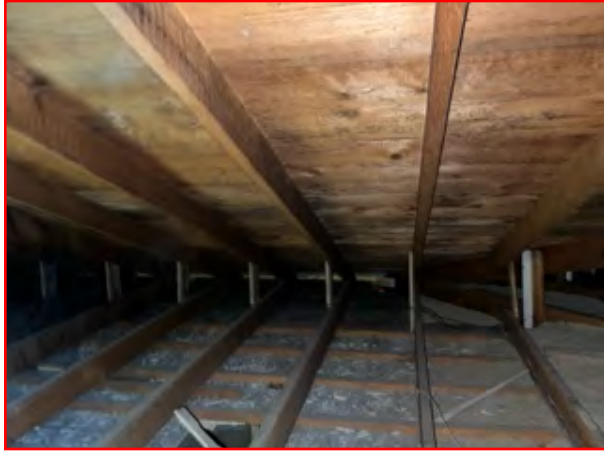
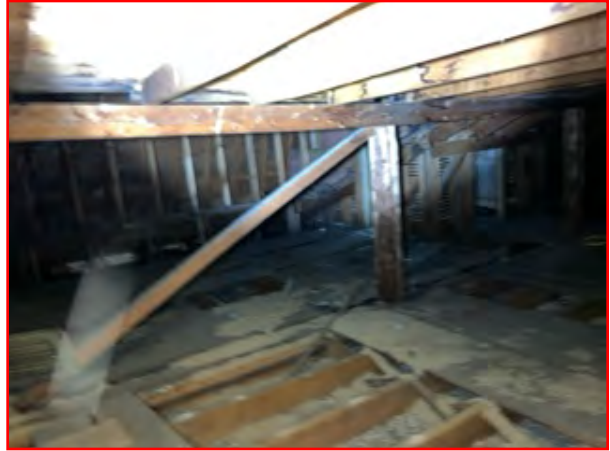
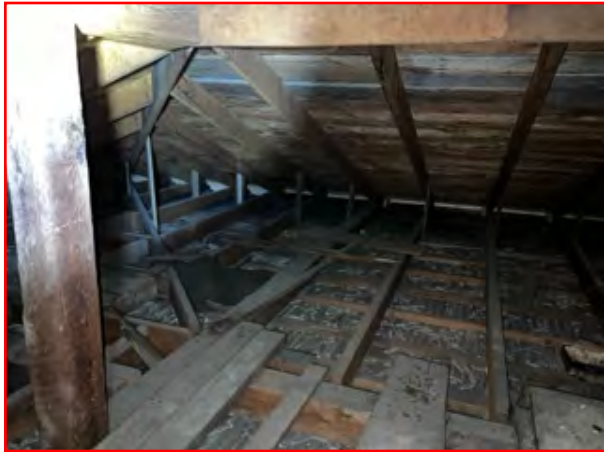
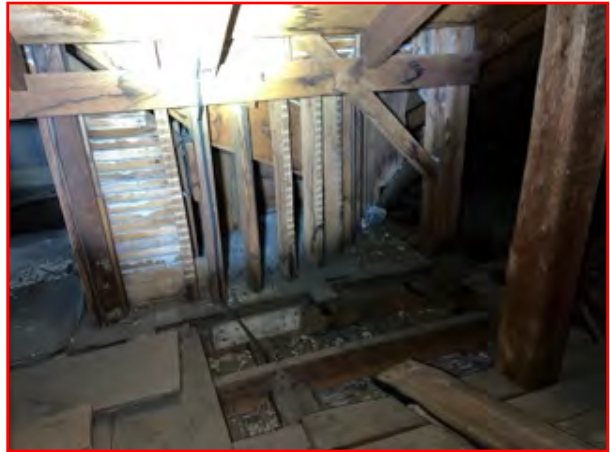
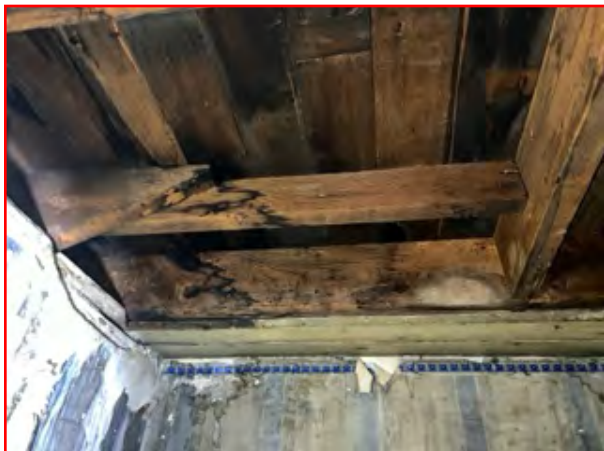
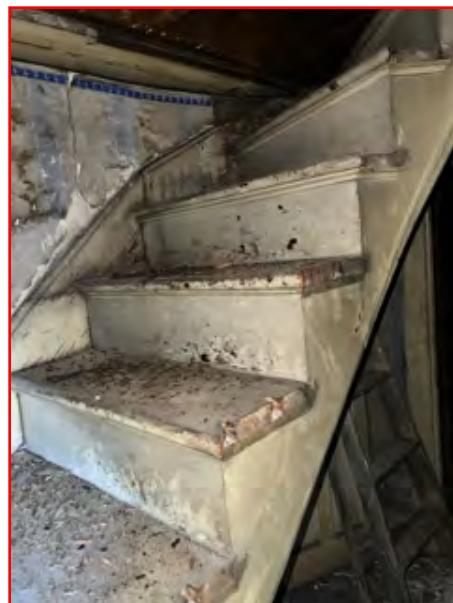
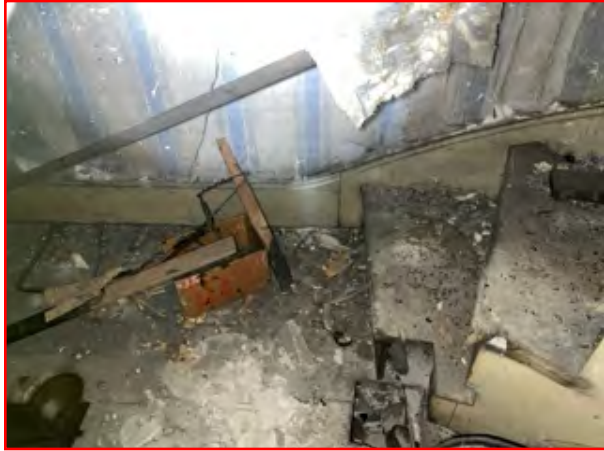
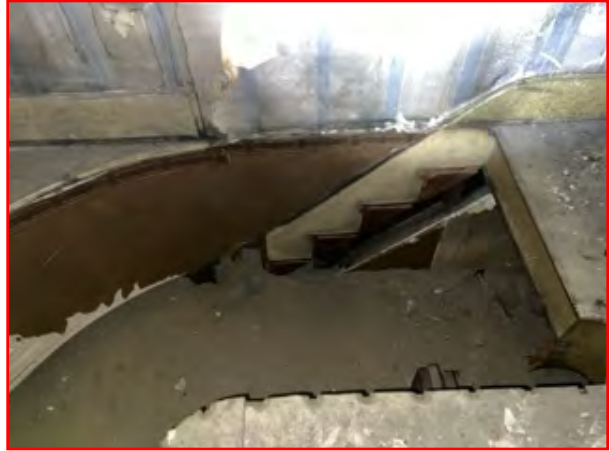
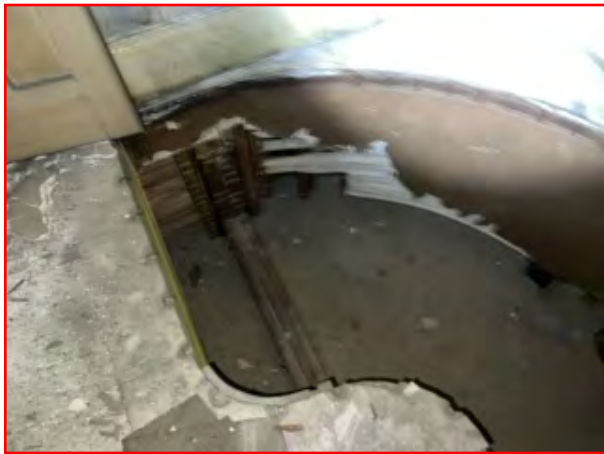
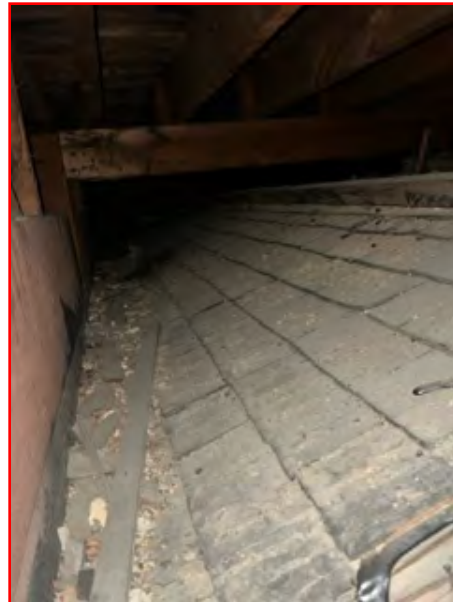
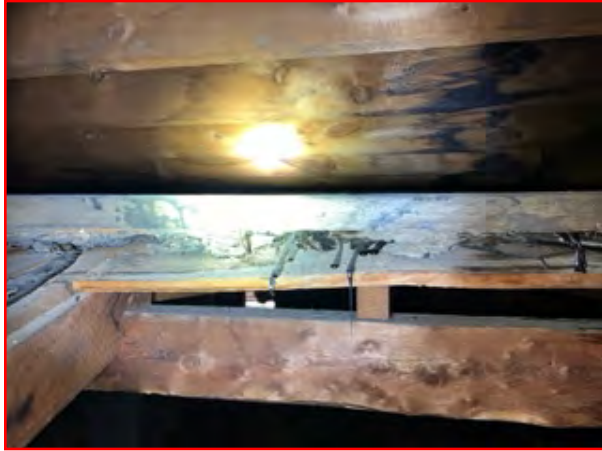
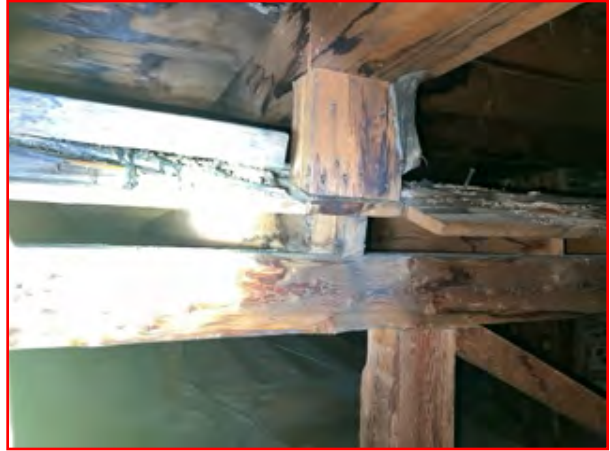
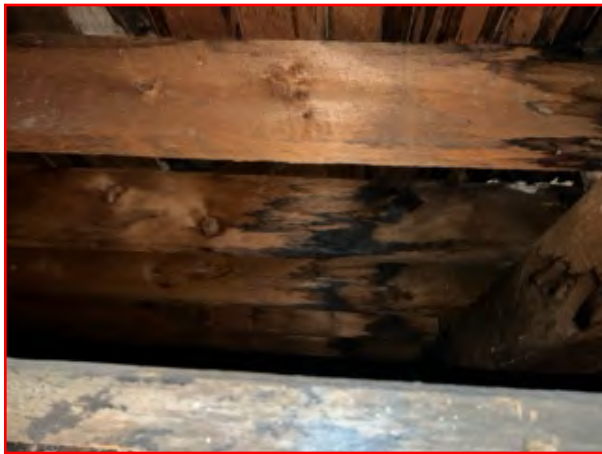
Structure: Attic

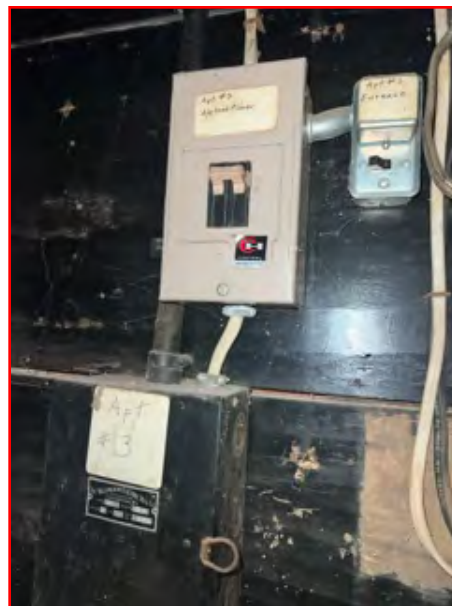
14) Pictures of the sub panels in the basement. Sub panels are used for the air conditioner and units number two and three. Unit number one has the air conditioner powered from the main panel.

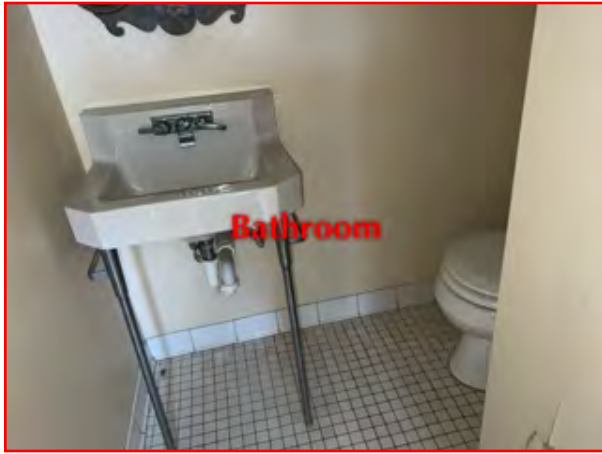
Figure 28-1

18) Picture of the bathroom to the first floor area.

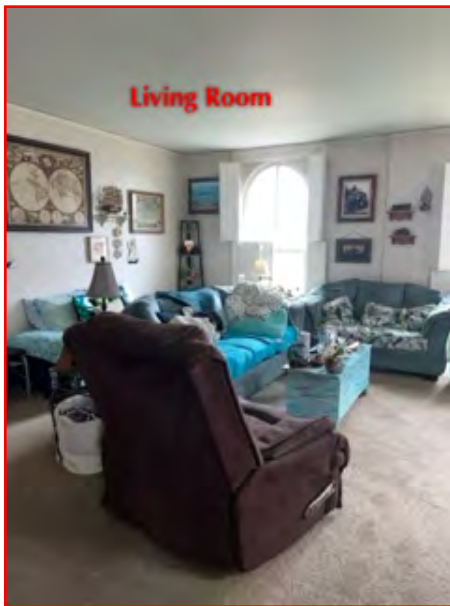
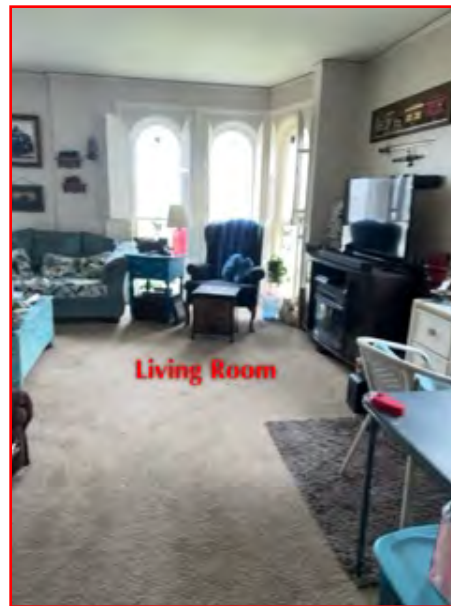
21) Pictures of the living room unit #3 .

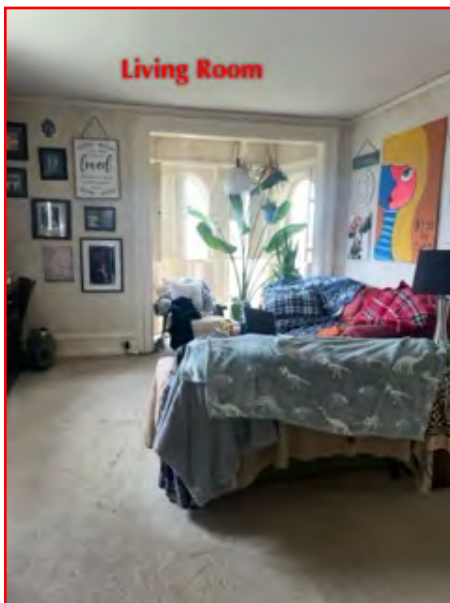
22) Pictures of the living room to Unit 2.

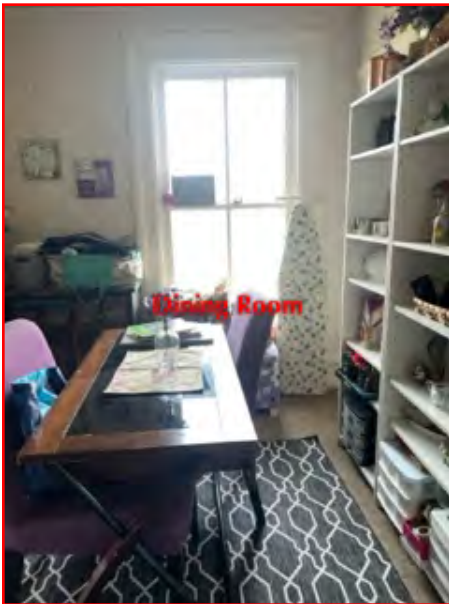
Figure 35-1

25) Picture of the dining room in Unit 3.

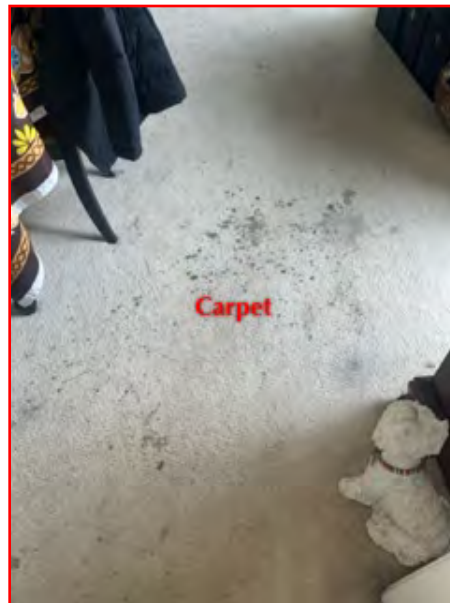
26) Picture of the dining room Unit 2.

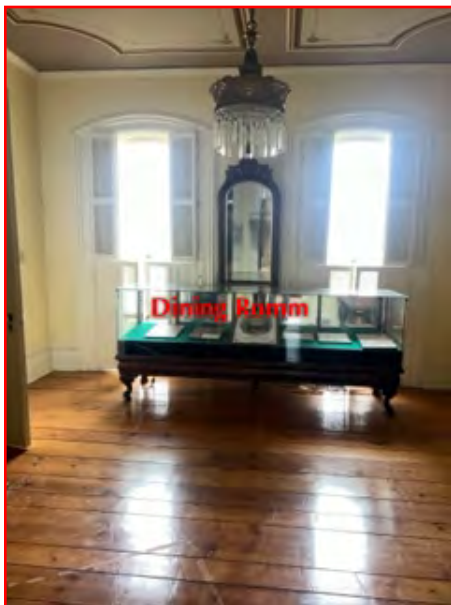
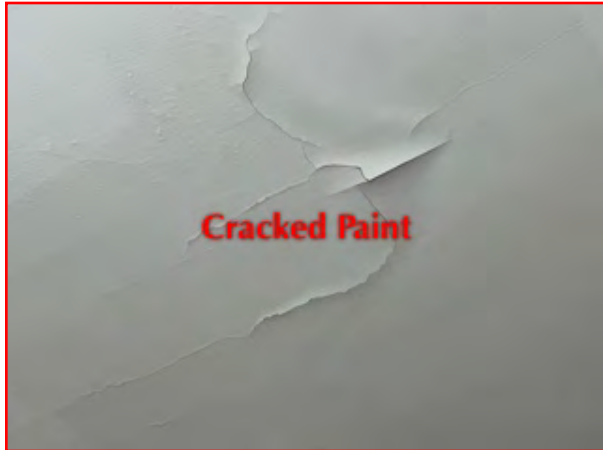
27) Picture of the dining room Unit 1.

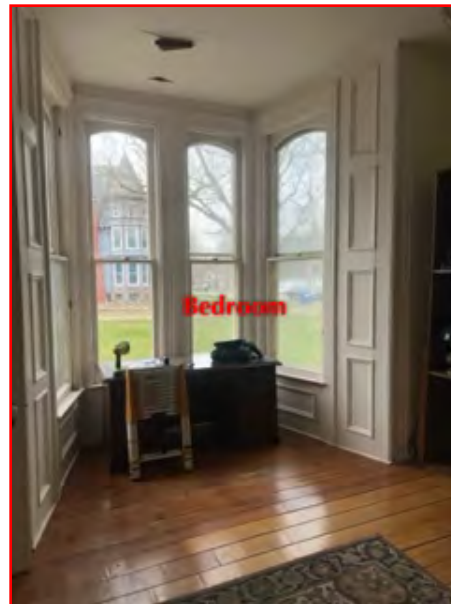
33) Unit 1.

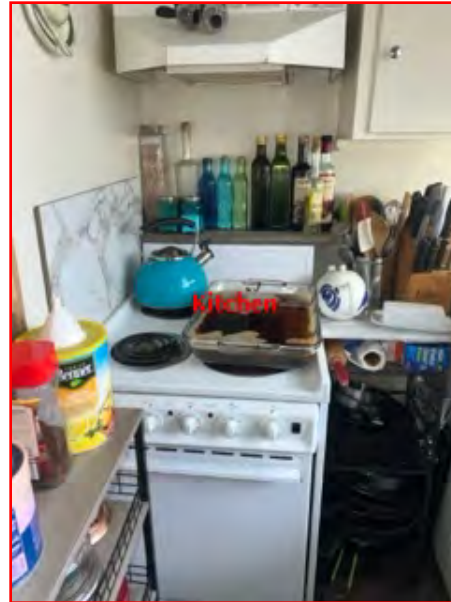
34) The GFCI outlet shows an open ground and does not trip when tested with a diagnostic tester.

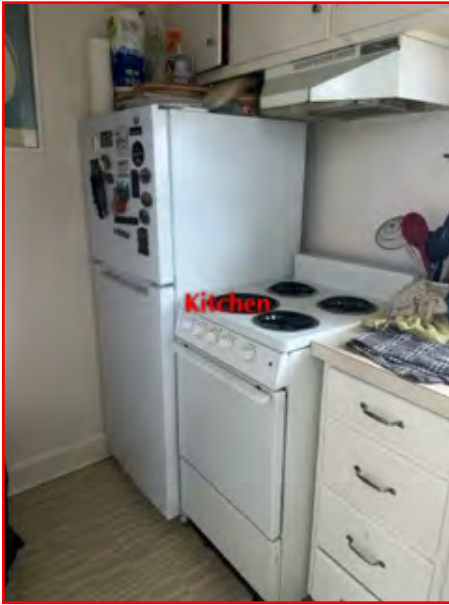
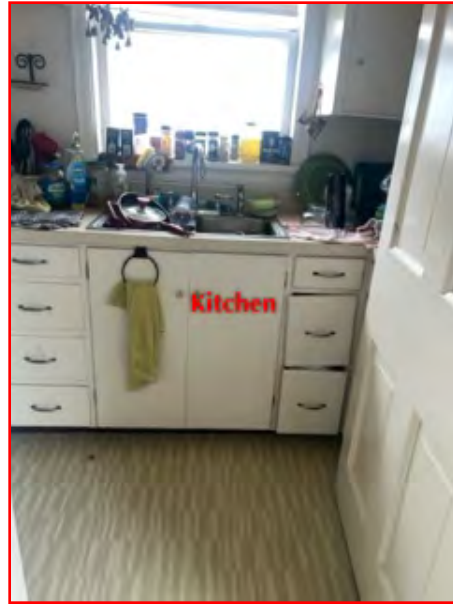
35) Unit 2.

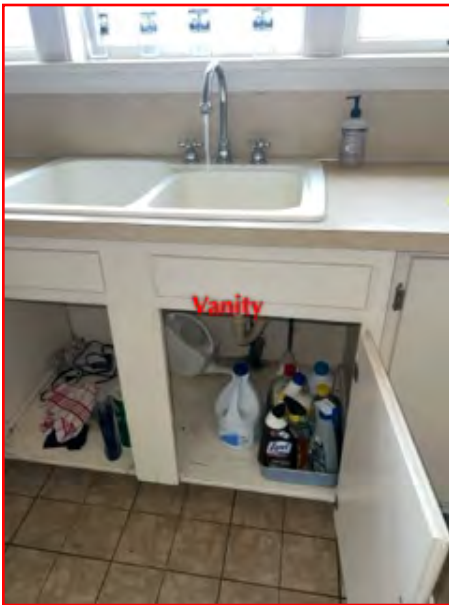
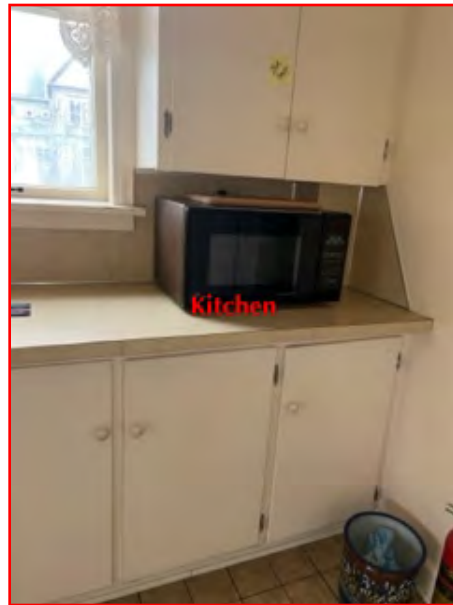
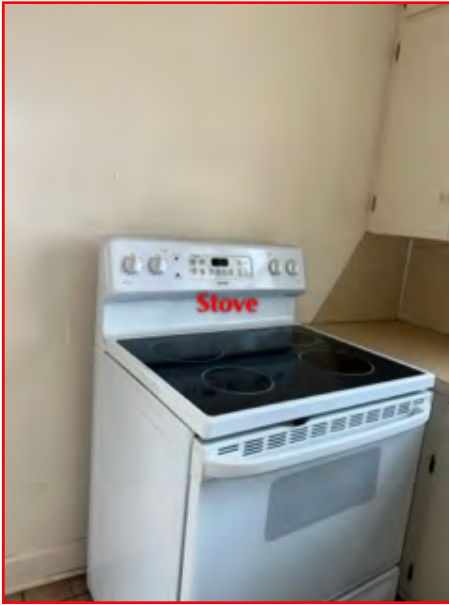
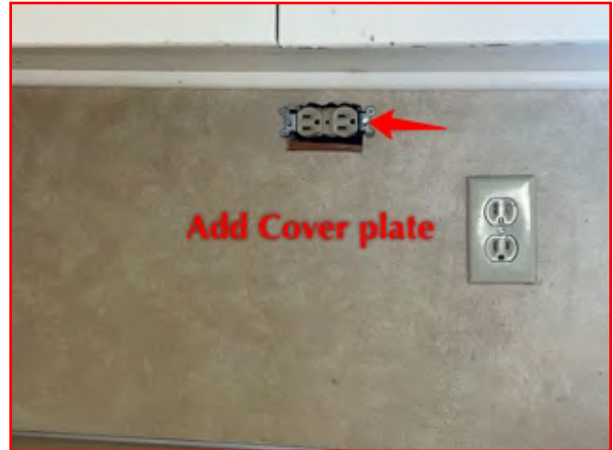
36) Unit 1.

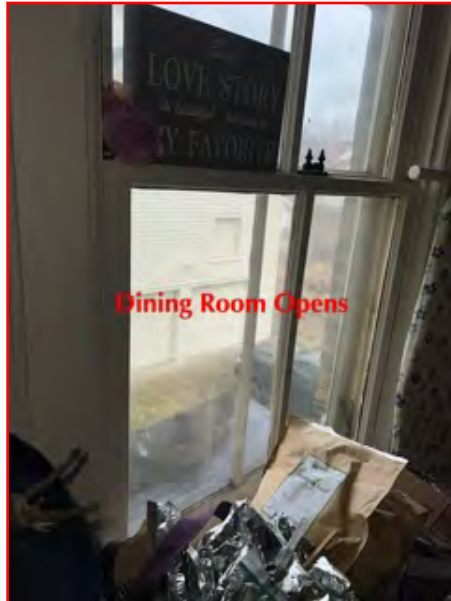
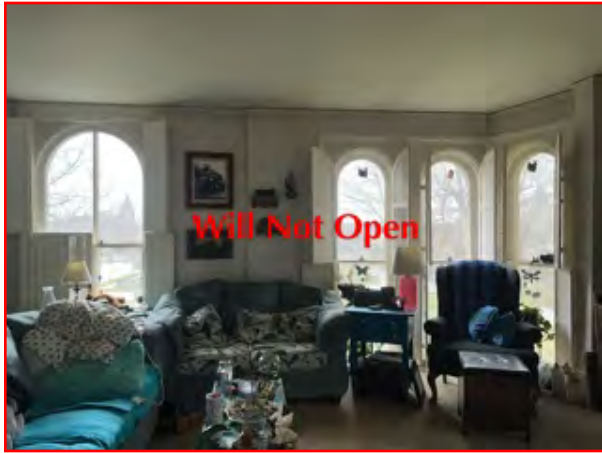
40) Most of the wood windows do not open in unit 3.

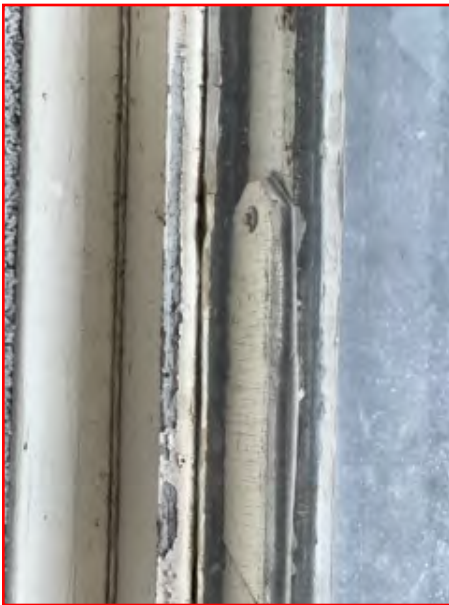
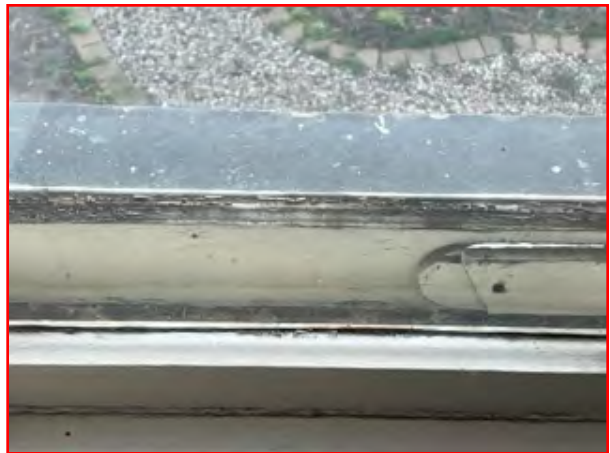
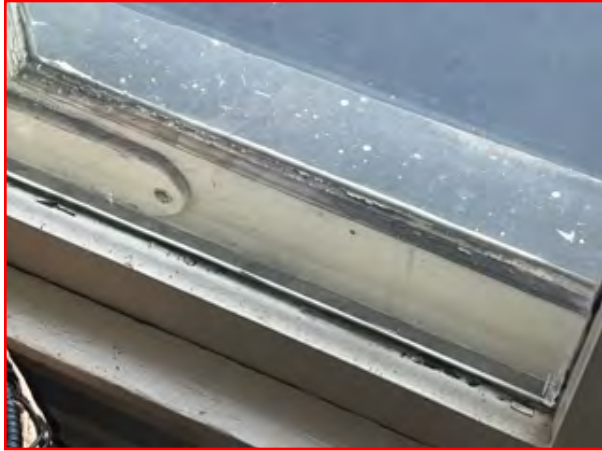
41) Most of the windows in unit number two will not open and peeling paint is present.
